LEAD BASED PAINT INSPECTION REPORT

DEPARTMENT OF HEALTH OF PUERTO RICO

SAMPLING CONDUCTED AT
SELECTIVE AREAS OF
DIAGNOSTIC AND TREATMENT CENTER
ADJUNTAS, PR

ZEM-19058

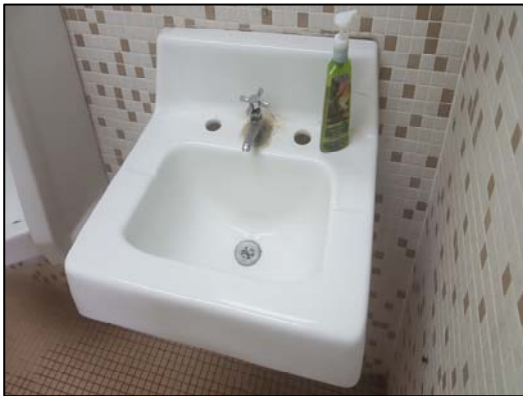
Medical Assistance *Public Men's Bathroom*
Lead containing ceramic lavatory

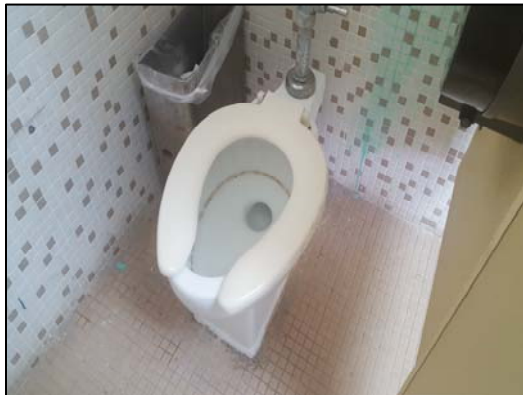
Medical Assistance *Public Men's Bathroom*
Lead containing ceramic toilet

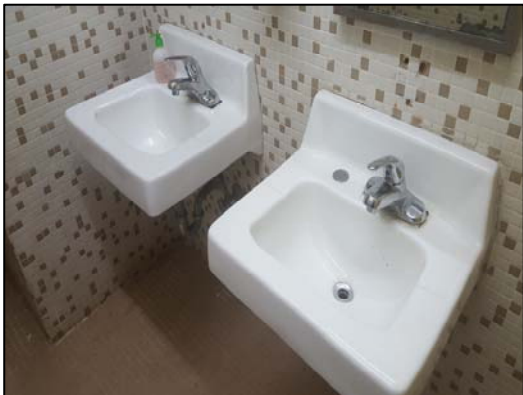
Medical Assistance *Public Women's Bathroom*
Lead containing ceramic lavatories

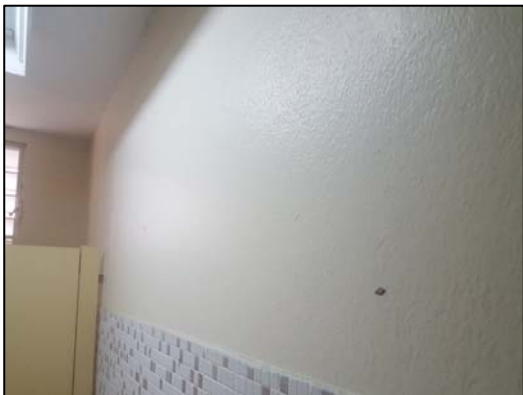
Medical Assistance *Public Women's Bathroom*
Lead based painted concrete wall

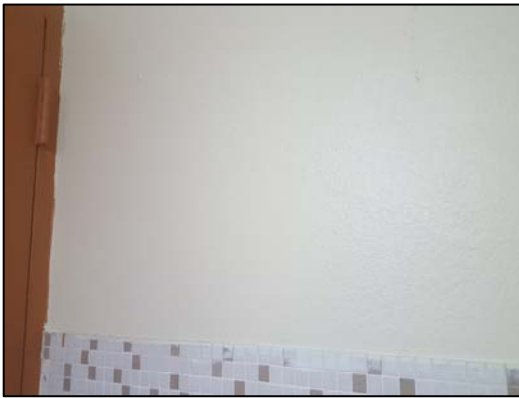
Medical Assistance Staff Women's Bathroom
Lead based painted concrete wall

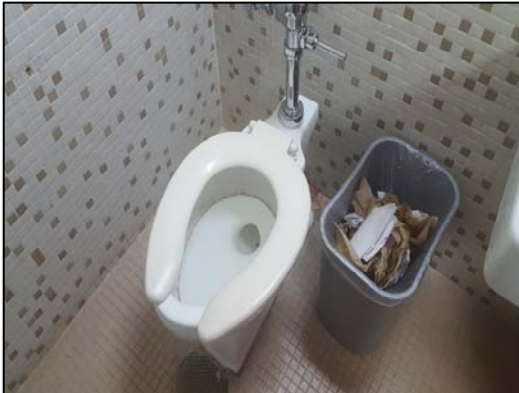
Medical Assistance Staff Women's Bathroom
Lead containing ceramic toilet

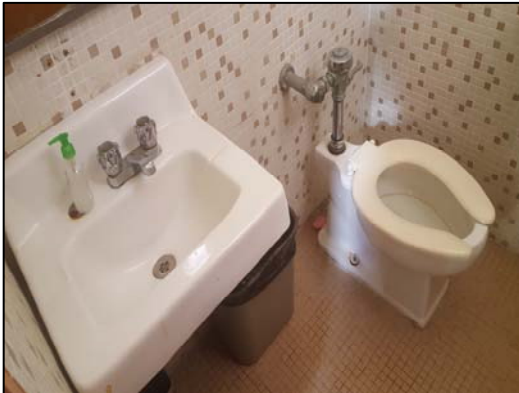
Medical Assistance Staff Men's Bathroom
Lead containing ceramic lavatory & toilet

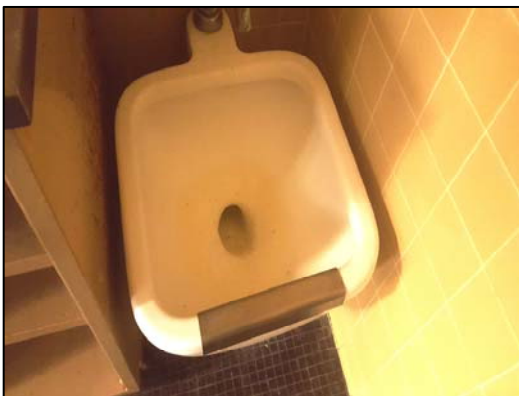
Newborns Delivery Room Area 1-5
Lead containing ceramic sink

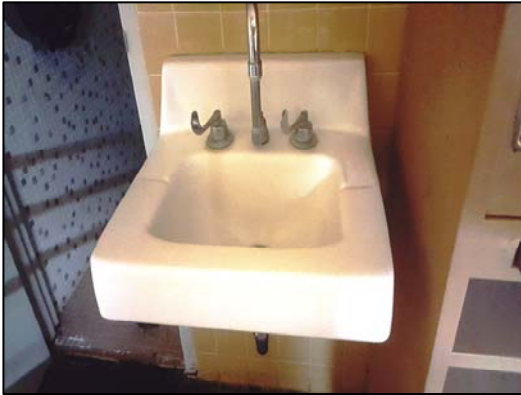
Newborns Delivery Room Area 1-9
Lead containing ceramic lavatory

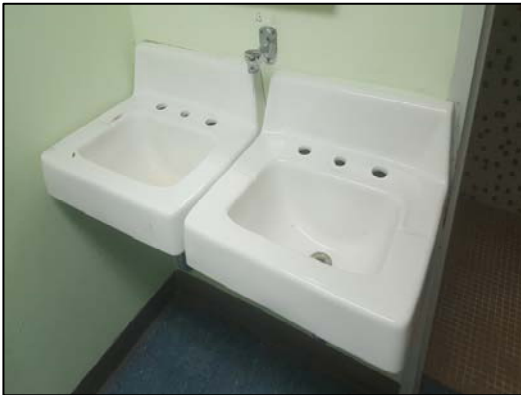
Newborns Delivery Room Area 1-13
Lead containing ceramic lavatories

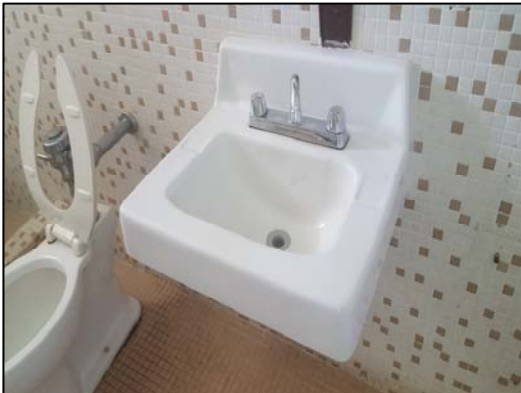
Newborns Delivery Room Area 1-16
Lead containing ceramic lavatory

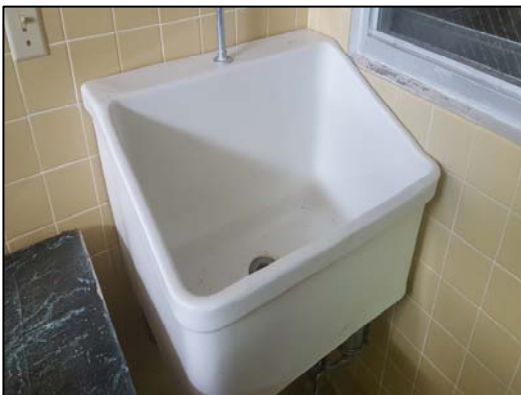
Newborns Delivery Room Area 1-23
Lead containing ceramic sink

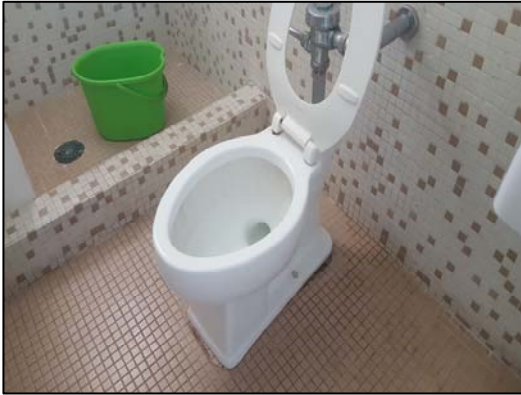
Newborns Delivery Room Area 1-25
Lead containing ceramic toilet
