# REPORTE DE INSPECCIÓN PINTURA EN BASE DE PLOMO

EN OFICINAS DEL DEPARTAMENTO DE SALUD  
MONACILLO URBANO, AVE. CENTRO MÉDICO, SAN JUAN P.R.

Septiembre, 2019

Preparado por:  
R & S Professional Equipment, Inc.  
PO Box 289, Naguabo, P.R. 00718  
Phone: (787) 637-7267  
Email. rsprofessionalequipment@gmail.com

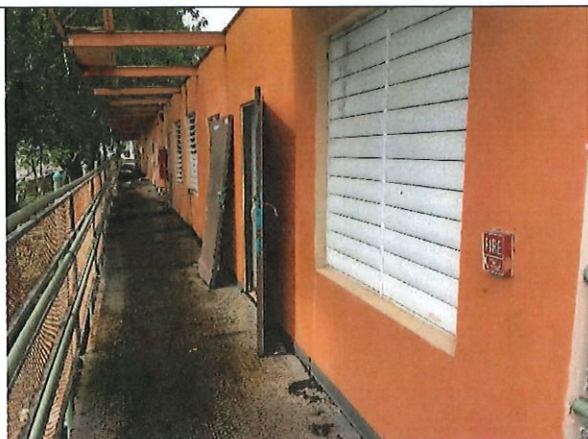
**Foto 1. Pasillo Pabellón 2, 2do nivel**

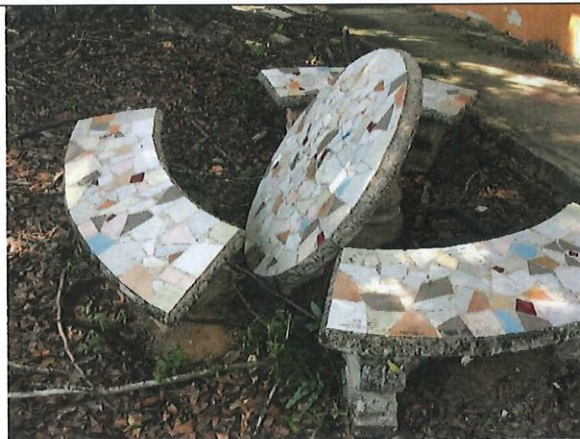
**Foto (2 sets) Bancos y mesa con cerámica  
LBP. Área de Pabellones**

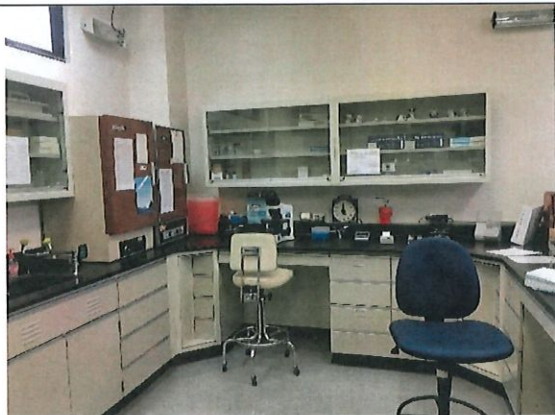
**Foto 7. con equipos con LPB.**

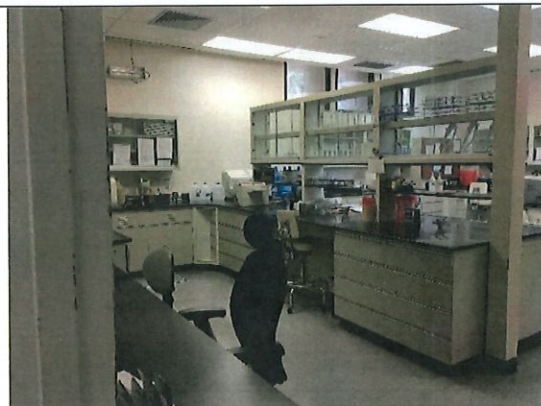
**Foto 8. Foto con equipos con LPB.**

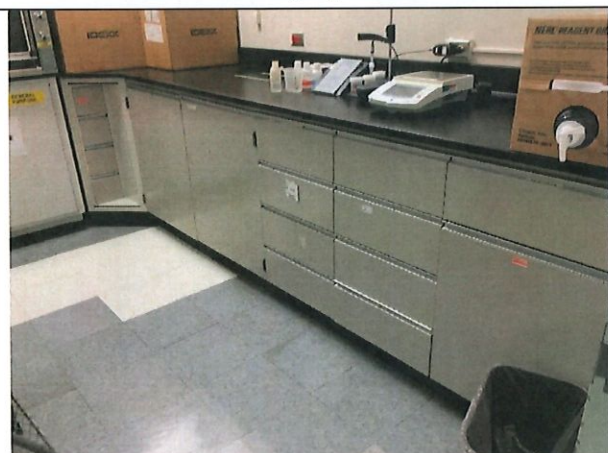
| <b>Estructuras</b> | <b>Cuarto</b> | <b>Sustrato</b> | <b>Color</b> | <b>Componentes</b> |
|---|---|---|---|---|
| | Cuarto Células Somáticas | Metal | Crema | Escritorio Interior |

**Foto 9. Escritorio (Cel. Soma.)**

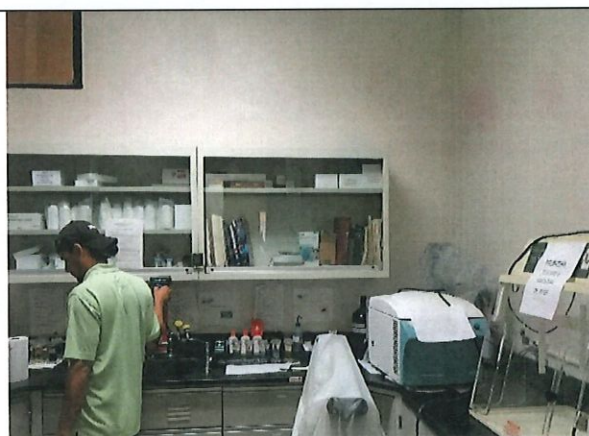
| <b>Estructuras</b> | <b>Cuarto</b> | <b>Sustrato</b> | <b>Color</b> | <b>Componentes</b> |
|---|---|---|---|---|
| | Parasitología | Metal | Crema | Armario Pequeño en la Pared |

**Foto 10. Closet en pared (Parasitología)**

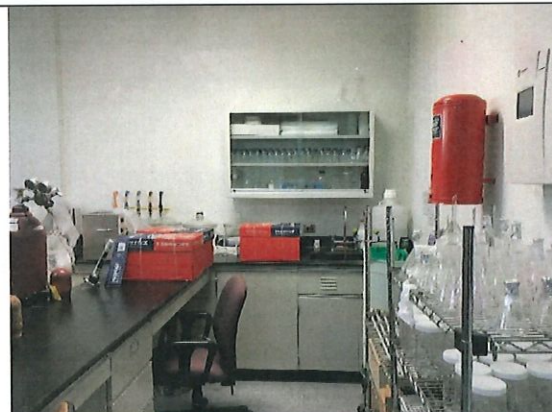
**Foto 12. Archivos de pared (Rec. Bact.)**

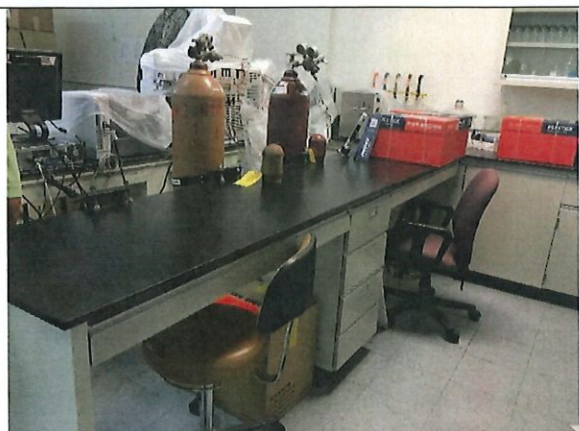
**Foto 13. Escritorios (Rec. Bact.)**

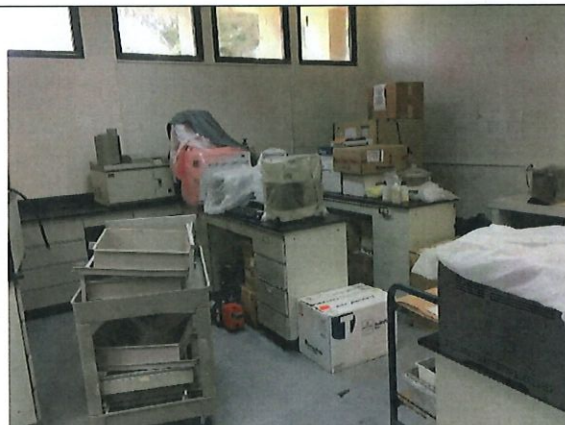
**Foto 14. Escritorios (Rec. Bact.)**

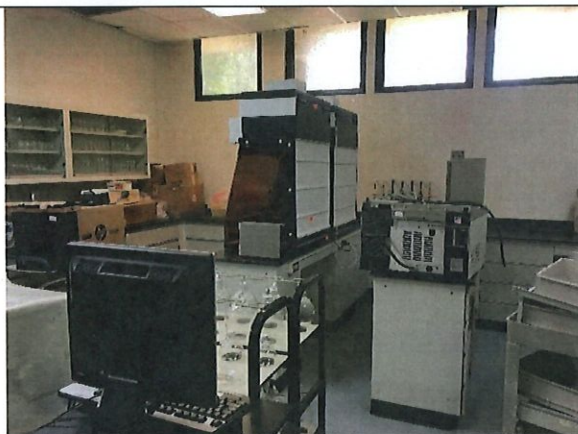
**Foto 15. Archivos de pared (Rec. Bact.)**

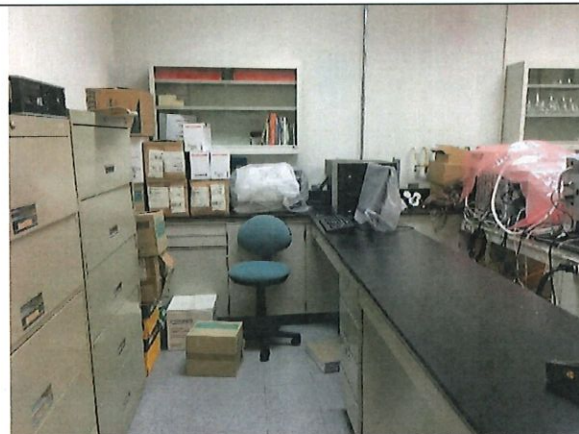
**Foto 16. Archivos y escritorios con LPB.**

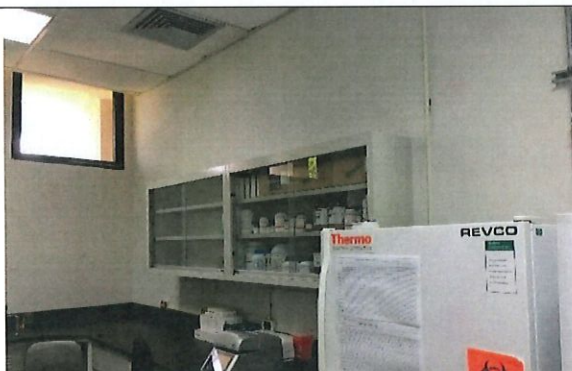
**Foto 17. Archivo de Pared (Extracciones Orgánicas)**

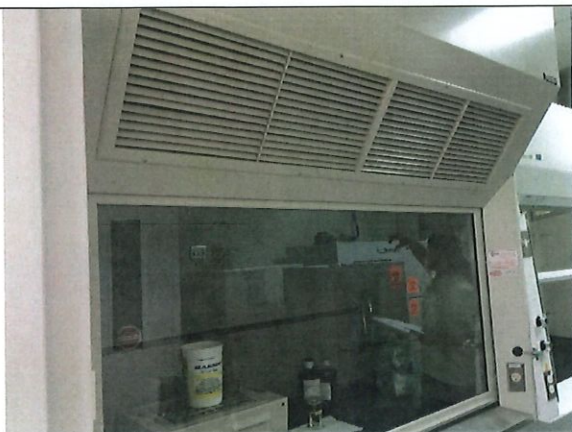
| <b>Estructuras</b> | <b>Cuarto</b> | <b>Sustrato</b> | <b>Color</b> | <b>Componentes</b> |
|---|---|---|---|---|
| | Cuartos Exteriores Org. | Metal | Crema | Campana de Extracción |

**Foto 19. Extractor  
(Extracciones Orgánicas)**

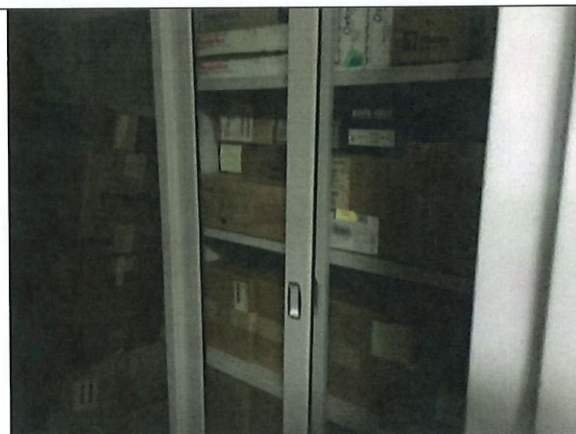
**Foto 20. Closet  
(Extracciones Orgánicas)**

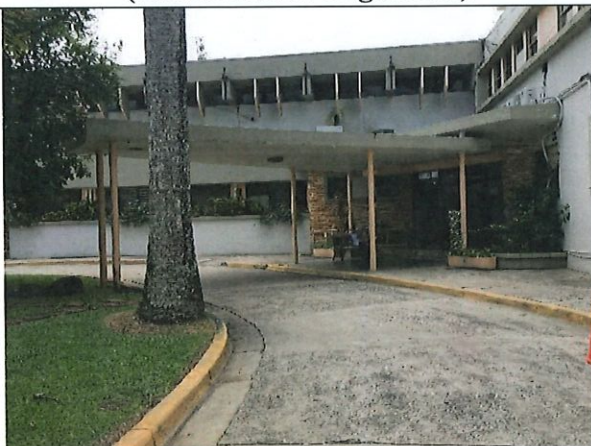
**Foto 21. Postes entrada.**

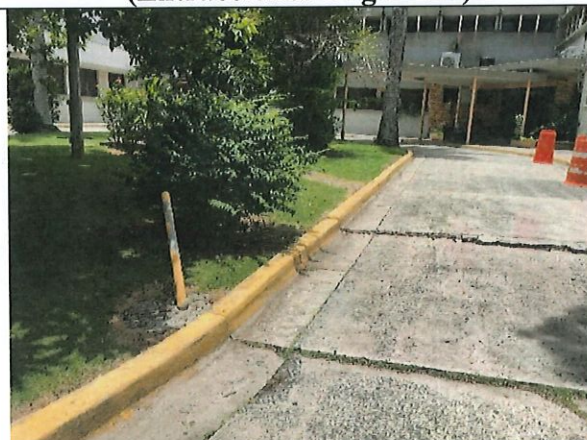
**Foto 22. "Bollard" 3 ft entrada.**

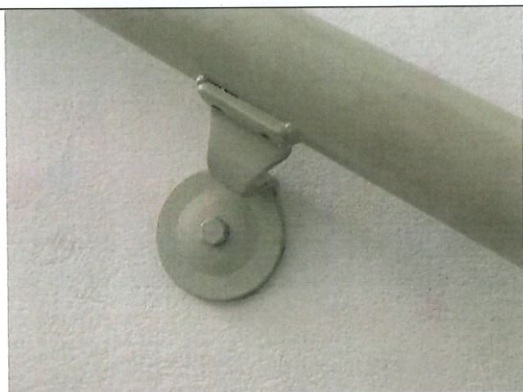
| Estructuras | Cuarto | Sustrato | Color | Componentes |
|---|---|---|---|---|
| | Escalera Salida<br>Emergencia Lab<br>Higiene | Metal | Crema | Soporte de Pasamano |

**Foto 23 soportes de pasamanos en escaleras  
de Lab. Higiene.**

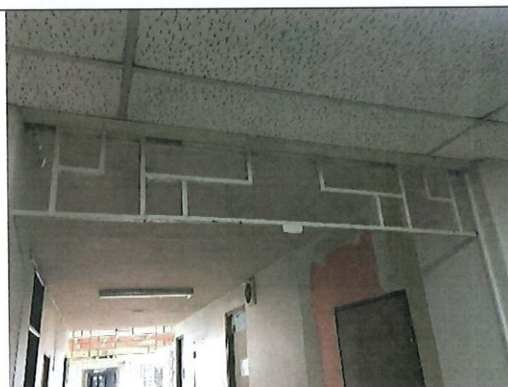
| Estructuras | Cuarto | Sustrato | Color | Componentes |
|---|---|---|---|---|
| | Pasillo hacia Cafetería | Metal | Crema | Baranda de Pasillo |

**Foto 24 áreas de Rejas de acero.  
Pasillo hacia Cafetería**

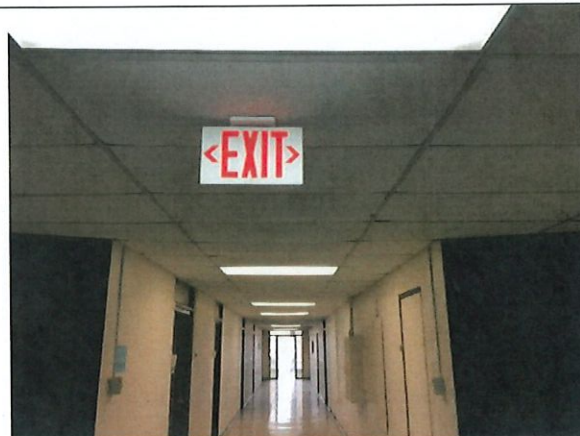
**Foto 26. Marcos de puertas**

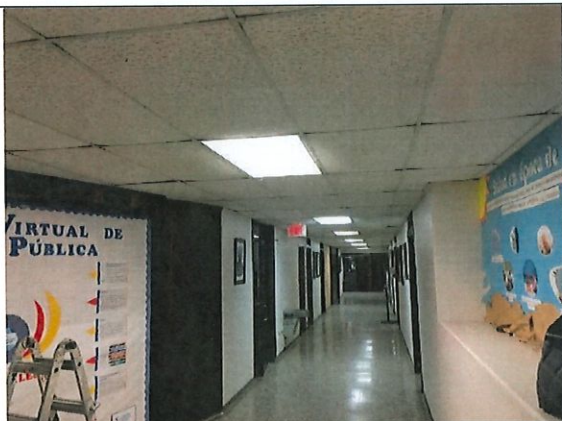
**Foto 27. Marcos de puertas**

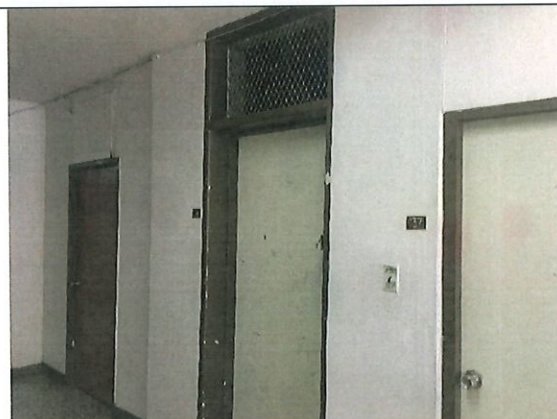
**Foto 28. Marcos de puertas.**

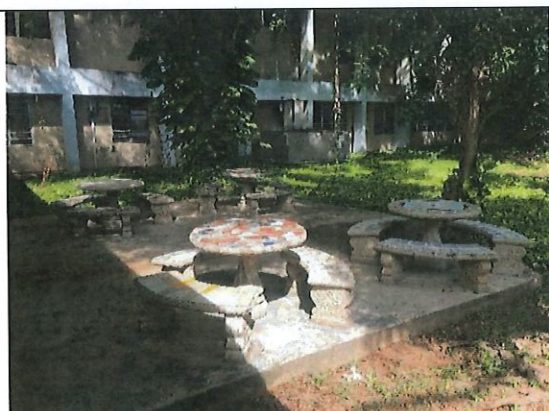
**Fotos 29. Cerámica en bancos y mesa de  
Patio Central**

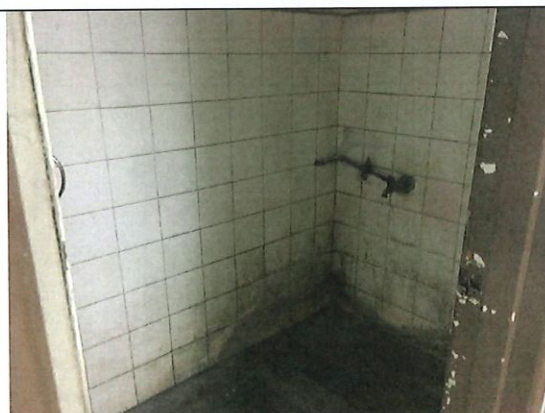
**Foto 30. de Cerámica en cobachas**

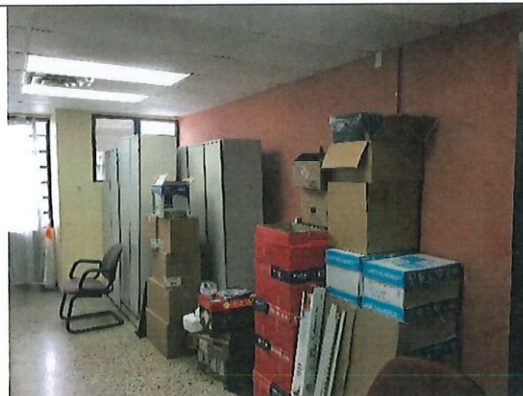
**Foto 32. LBP en pared de concreto en Oficina 128**

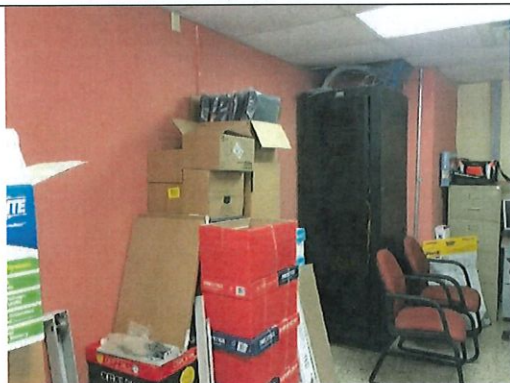
**Foto 33. LBP en pared de concreto en Oficina 128**

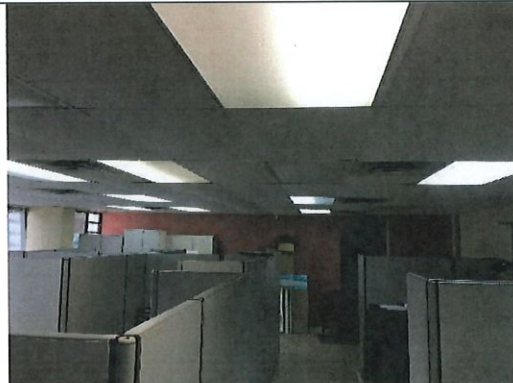
**Foto 34. LBP en pared de concreto en Oficina 128**

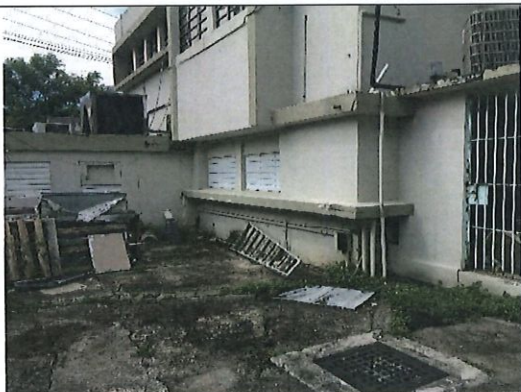
**Foto 37. LBP en "Exterior Eave", Area Sur, Subestación Eléctrica y Salud.**

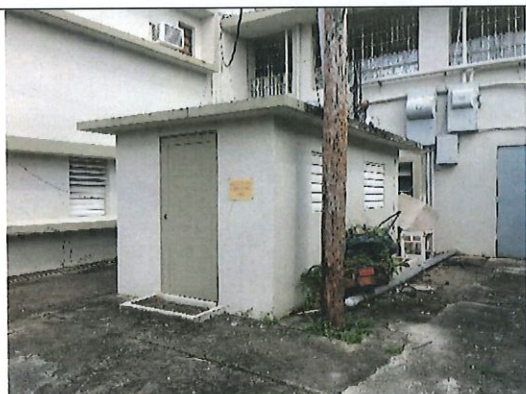
**Foto 39. Covacha frente a Subestación Eléctrica. Paredes A, D.**

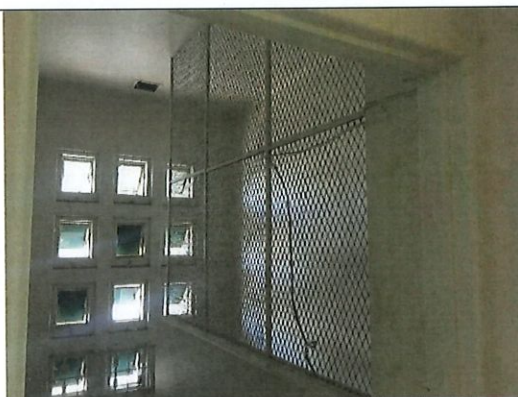
**Foto 40. Escalera hacia sótano. LBP en reja y pasamanos.**

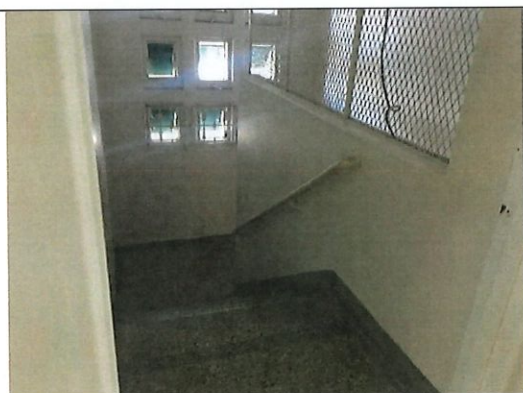
**Foto 41. Escalera hacia sótano. LBP en reja y pasamanos.**

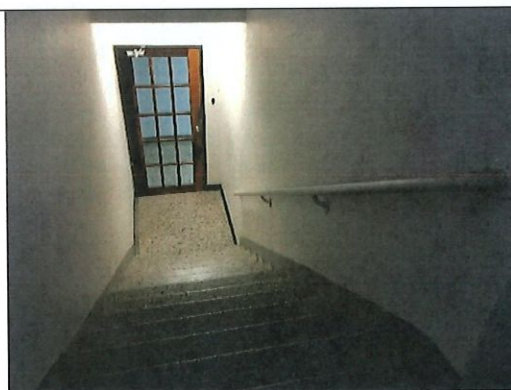
**Foto 42. Escalera hacia sótano. LBP en reja y pasamanos.**

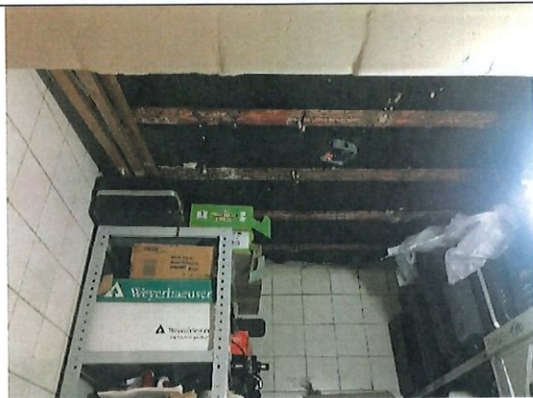
**Foto 43. Cerámica de dos Closets área Salud Radiológica y Sonósis. Sótano**

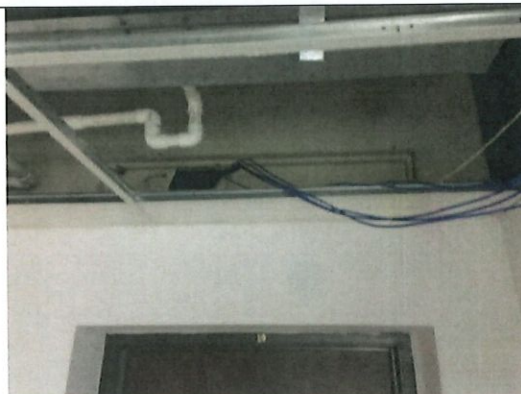
**Foto 44. Marco de puerta área Salud Radiológica y Sonósis. Sótano**

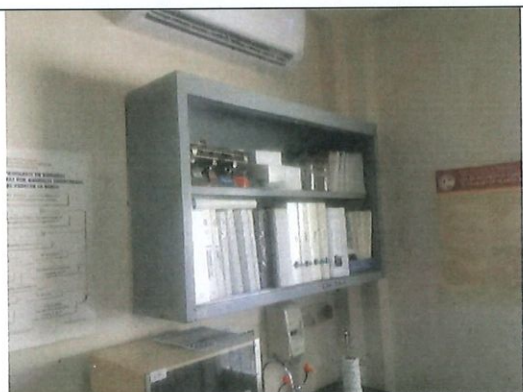
| Estructuras | Cuarto | Sustrato | Color | Componentes |
|---|---|---|---|---|
| Edificio Lab. Rabia | Lab. Rabia | Metal | Gris | Pared de Gabinetes |

**Foto 45. Gabinete de pared, Área de Laboratorio de Rabia**

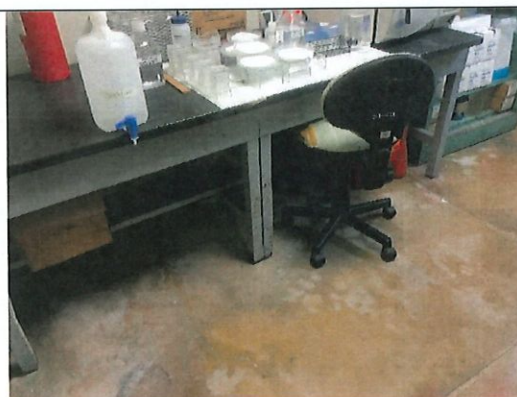
| Estructuras | Cuarto | Sustrato | Color | Componentes |
|---|---|---|---|---|
| | | Metal | Gris | Mesa de Trabajo |

**Foto 46. Mesa de trabajo Área de Laboratorio de Rabia**

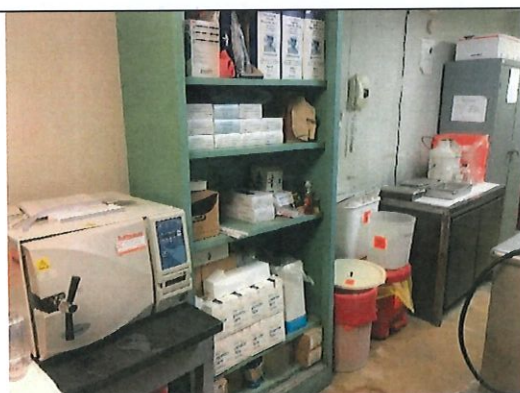
| Estructuras | Cuarto | Sustrato | Color | Componentes |
|---|---|---|---|---|
| | | Metal | Gris | Piso de Archivo |

**Foto 47. Archivo de trabajo Área de Laboratorio de Rabia**

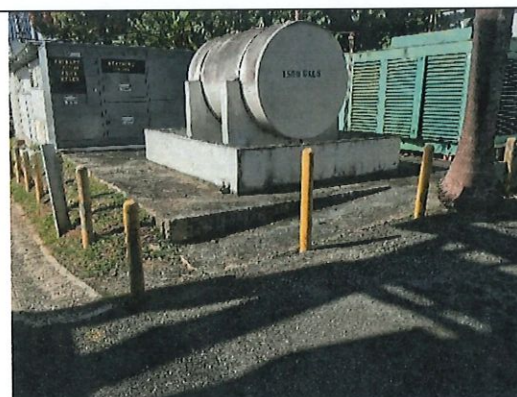
**Foto 48. Bolardos con LBP amarillo (10 ea.)**

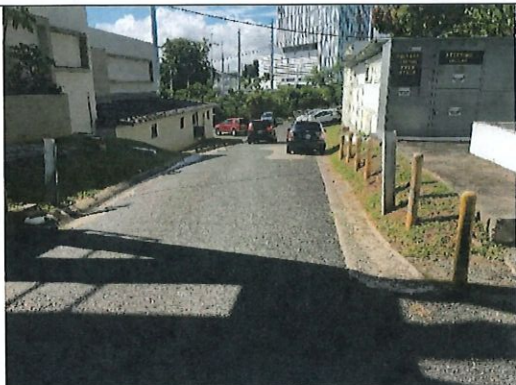
| Estructuras | Cuarto | Sustrato | Color | Componentes |
|---|---|---|---|---|
| | | Metal | Gris | Vigas de Suelo |

**Foto 49. (2) vigas incrustadas en suelo.**

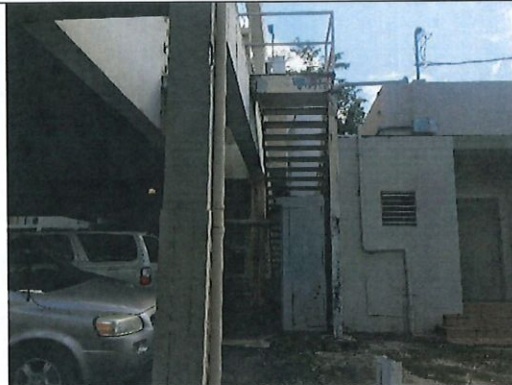
**Foto 50. Poste de escalera con LBP.**

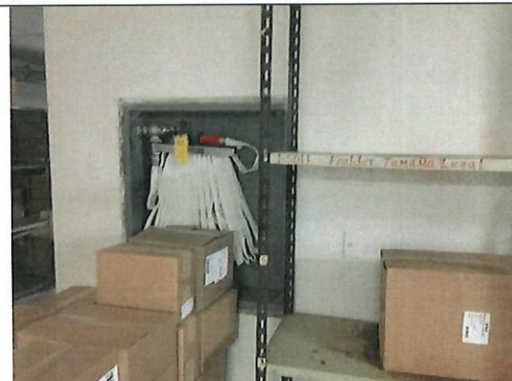
| Estructuras | Cuarto | Sustrato | Color | Componentes |
|---|---|---|---|---|
| | | Metal | Crema | Estación de Incendio |

**Foto 52. Caja de "Fire Station" con LBP.**

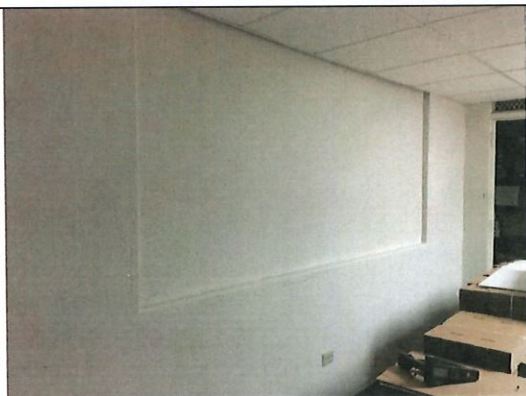
**Foto 53. Marco con LBP. Área de Almacén.**

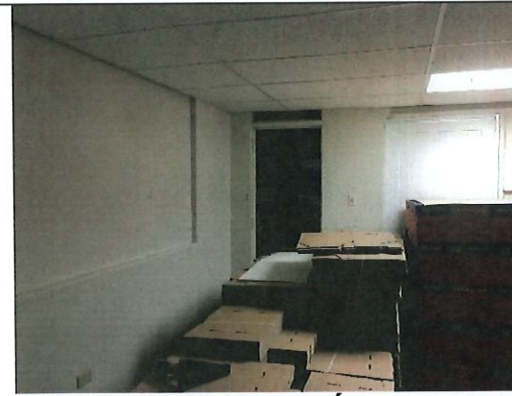
**Foto 54. Marco con LBP. Área de Almacén.**

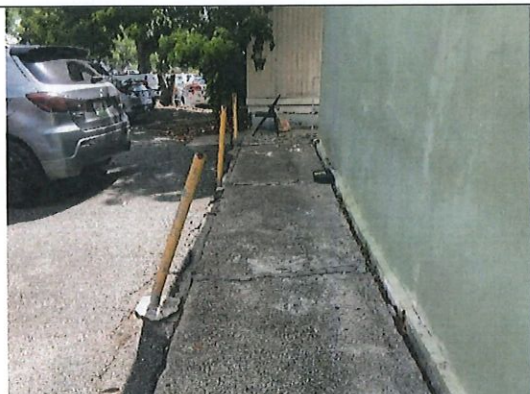
**Foto 55. (5) Bolardos y (5) Wheel stop, con LBP en área de Pabellones.**

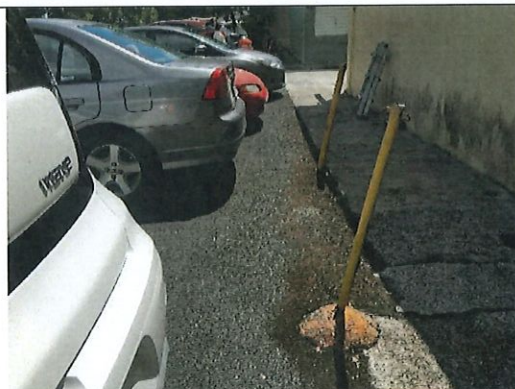
**Foto 56. (5) Bolardos y (5) Wheel stop, con LBP en área de Pabellones.**

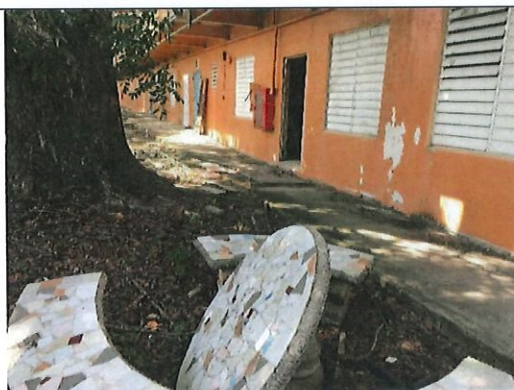
**Foto 57. (2 sets) de mesa y banco con LBP en Cerámica. Entre Pabellón 2 y 3.**

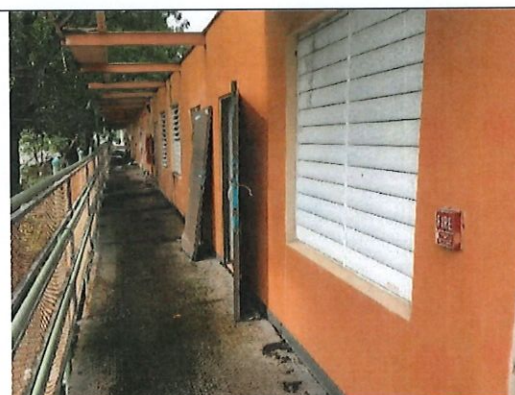
**Foto 58. Pasillo Pabellón 2, 2do nivel.**

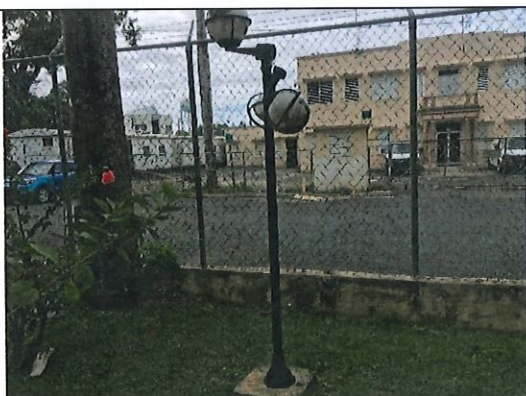
**Foto 59. Poste con alumbrado con LBP. Entrada Norte**

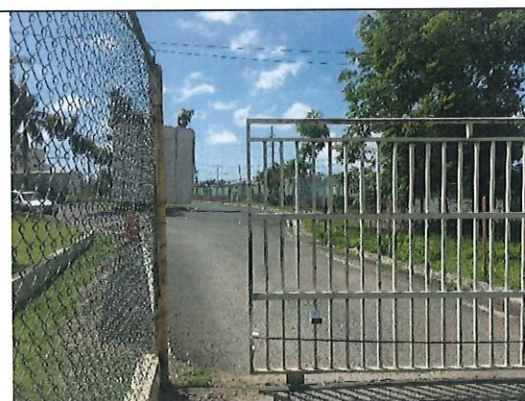
**Foto 60. Poste con LBP (4) en portón de entrada área sur**

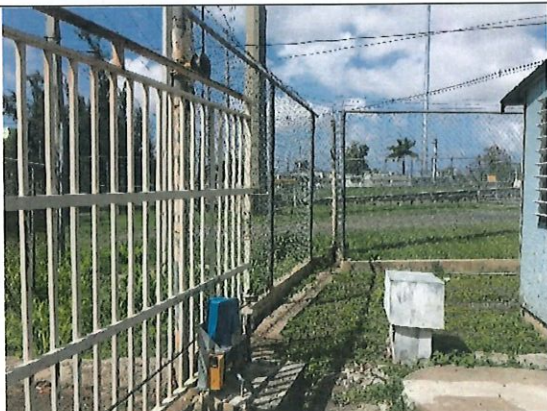
**Foto 61. Poste con LBP (4) en portón de entrada Área Sur.**

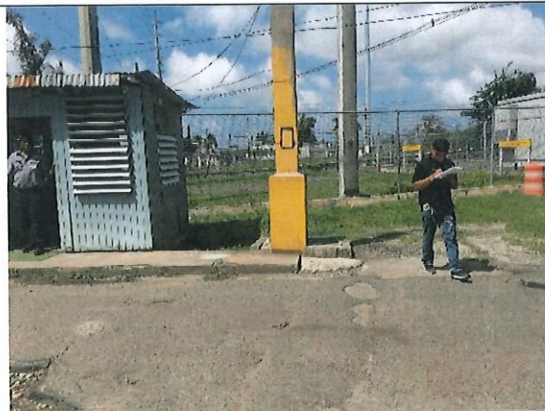
**Foto 62. LBP en muro de poste en entrada Área Sur.**

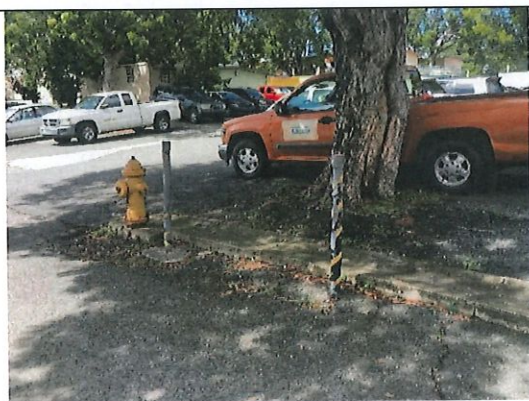
| Estructuras | Cuarto | Sustrato | Color | Componentes |
|---|---|---|---|---|
| | | Metal | Amarillo | Hidrante |

**Foto 65. Hidrante y Bolardos con LBP amarillo en estacionamientos. Área Norte.**

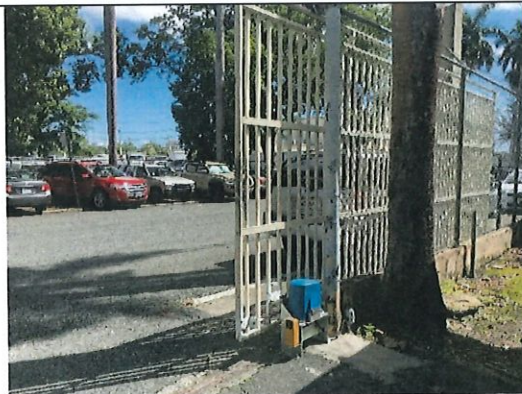
**Foto 66 Poste de portón con LBP amarillo en estacionamientos. Área Norte.**

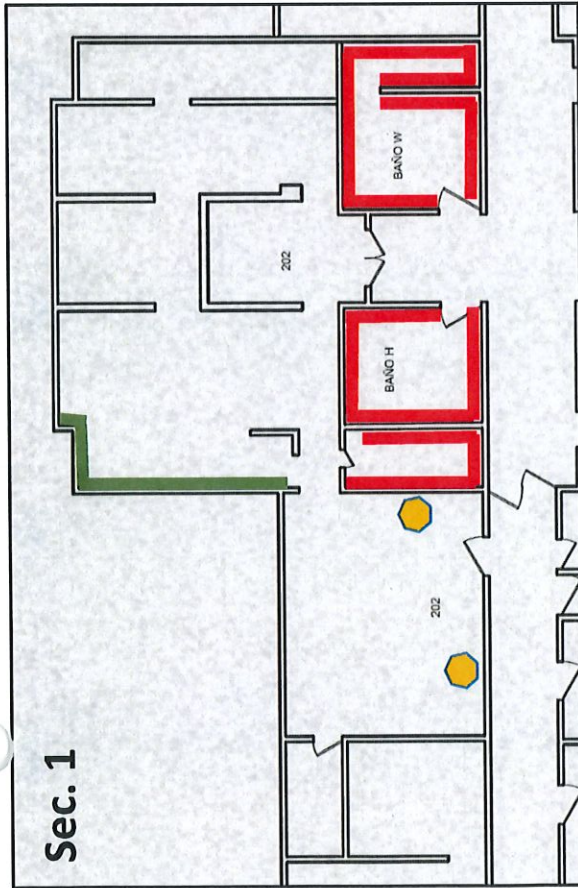
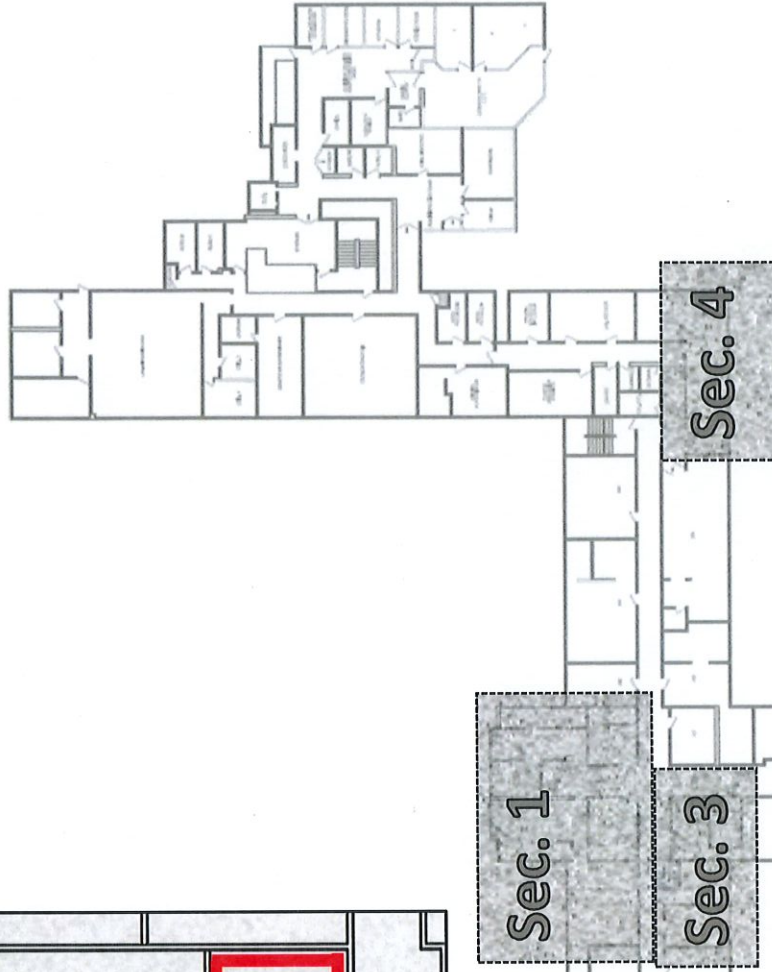
**Leyenda: Edificio Principal Piso 2, Área de Laboratorios**

Se presentan las siguientes áreas positiva a LBP.

-7/30/19-R#64. (Room 202 Wall Cabinets)

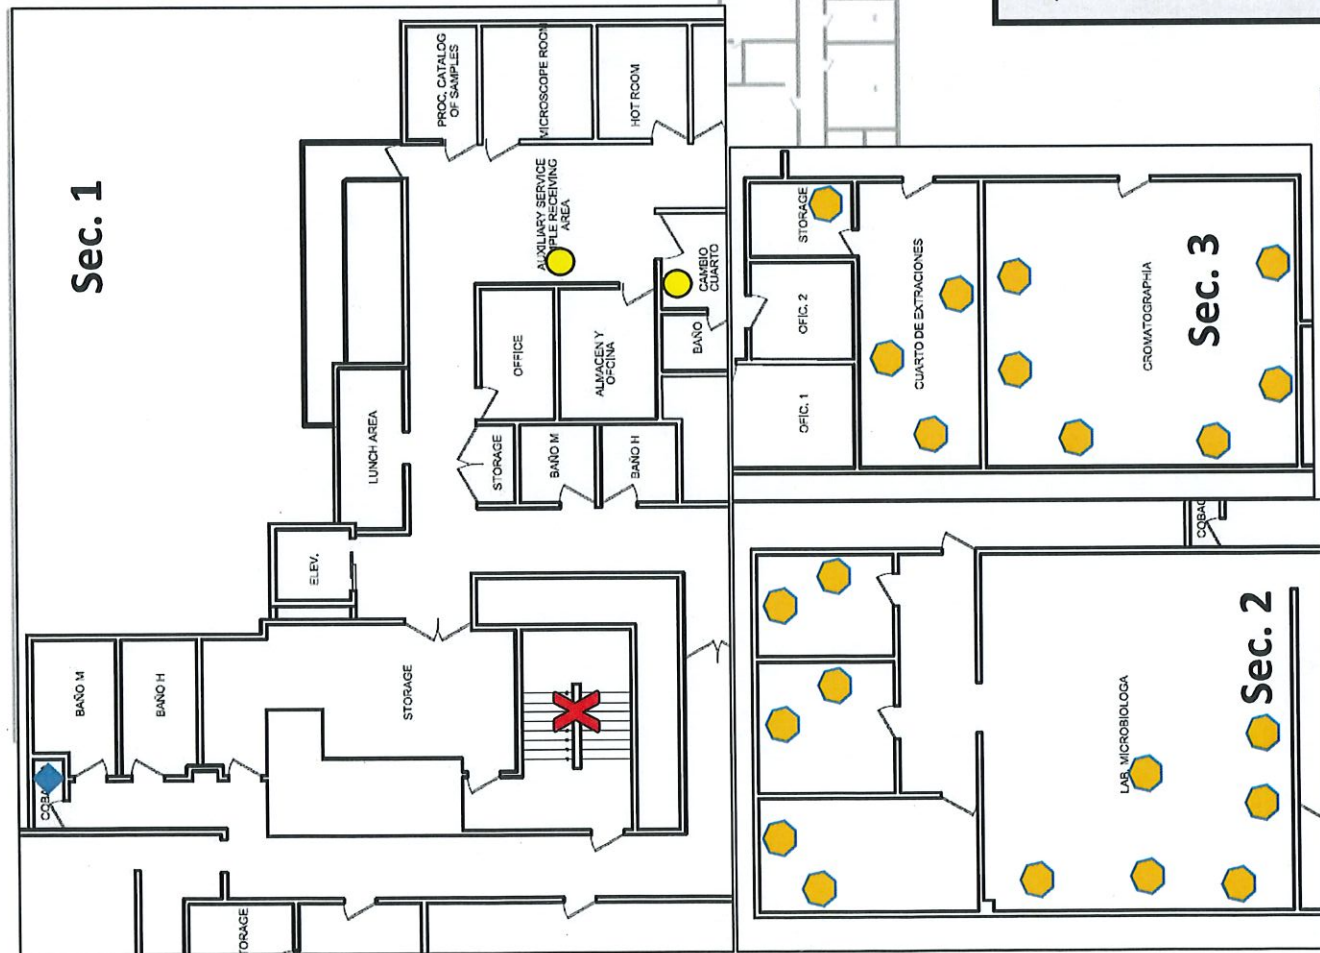
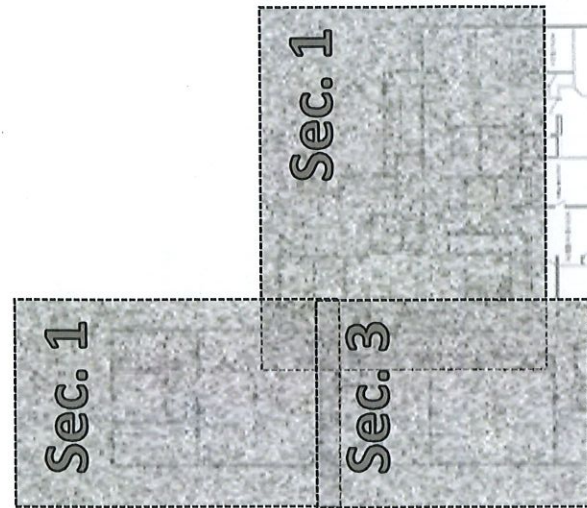
## Legenda: Edificio Principal Piso 2, Área de Laboratorios. Parte 2

Se presentan las siguientes áreas positiva a LBP.

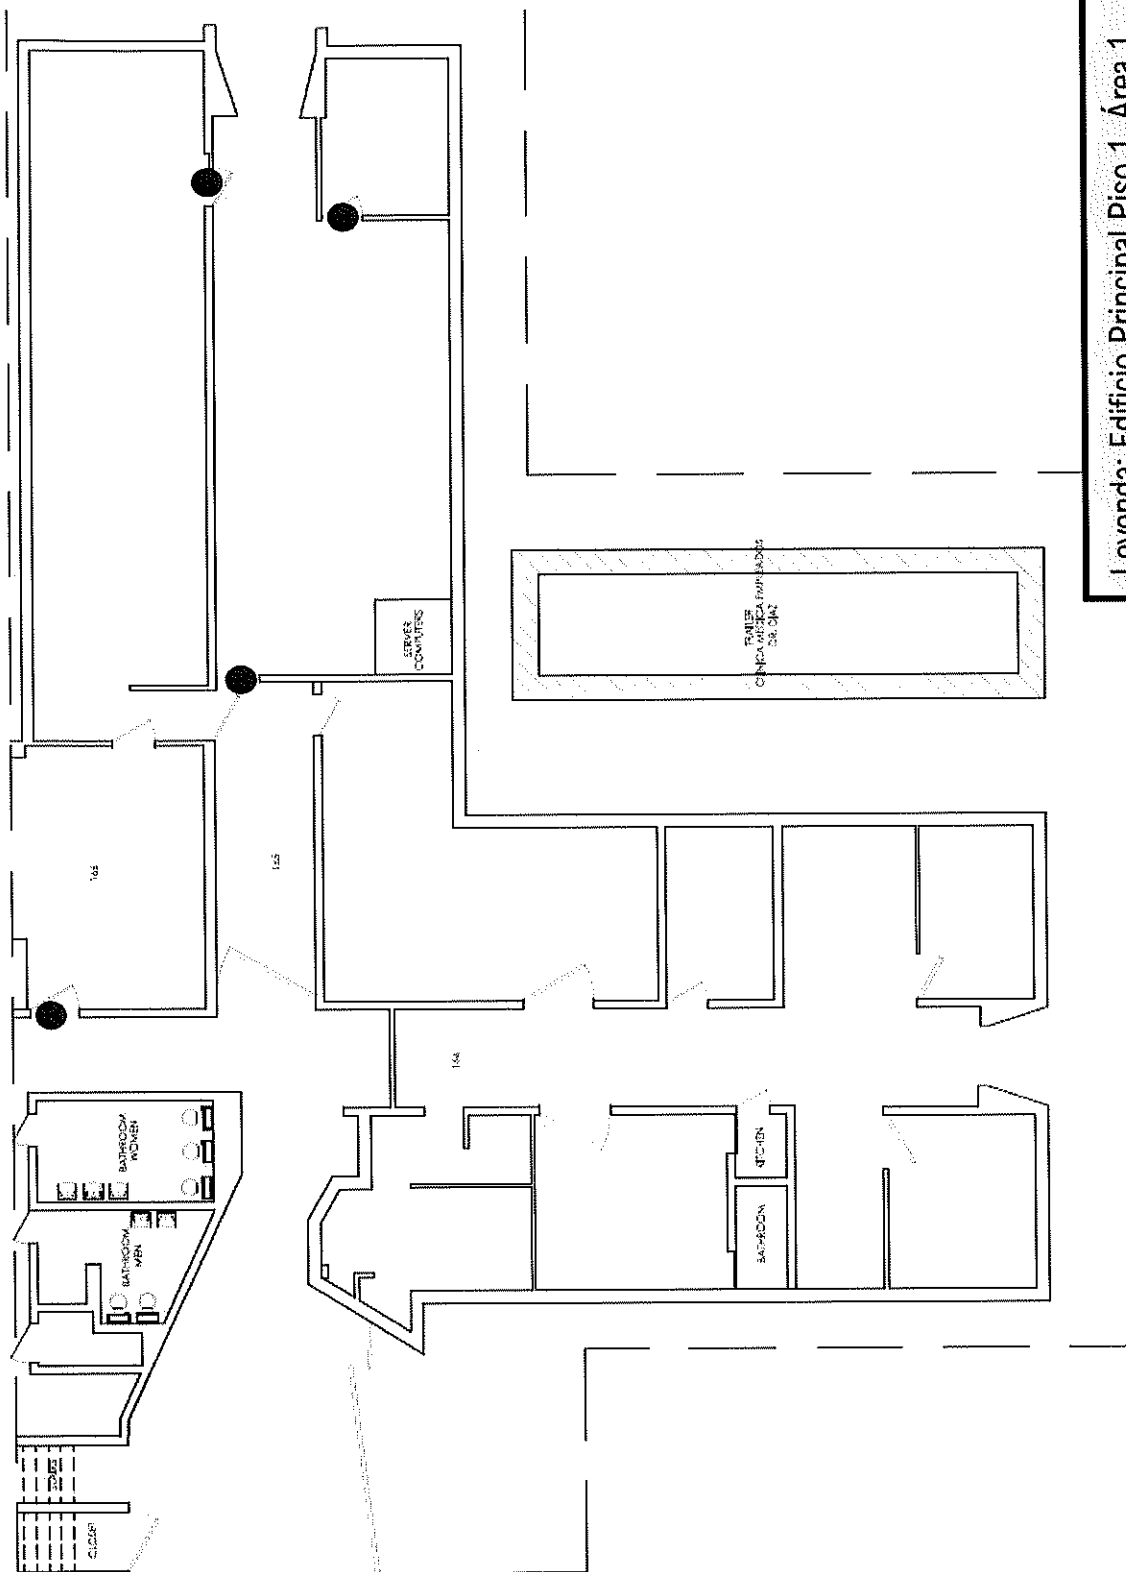
**Legenda: Edificio Principal Piso 1, Área 1.**

Se presentan las siguientes áreas positiva a LBP.

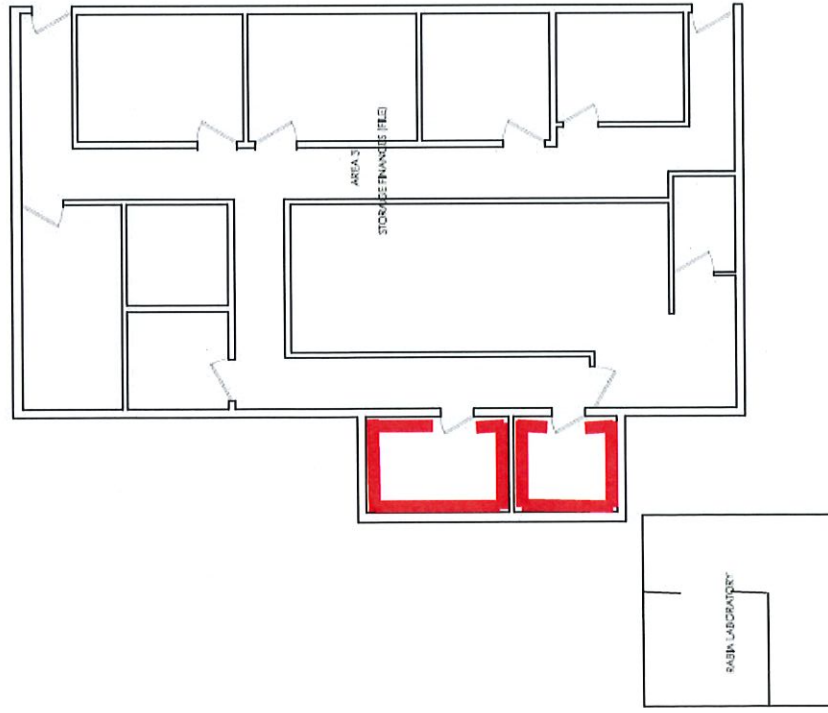
**Leyenda:** Edificio Principal Piso 1, y Edificio de Almacén de Finanzas en Área Sur del Exterior. Área 3 en Plano Esquemático.

Se presentan las siguientes áreas positiva a LBP.

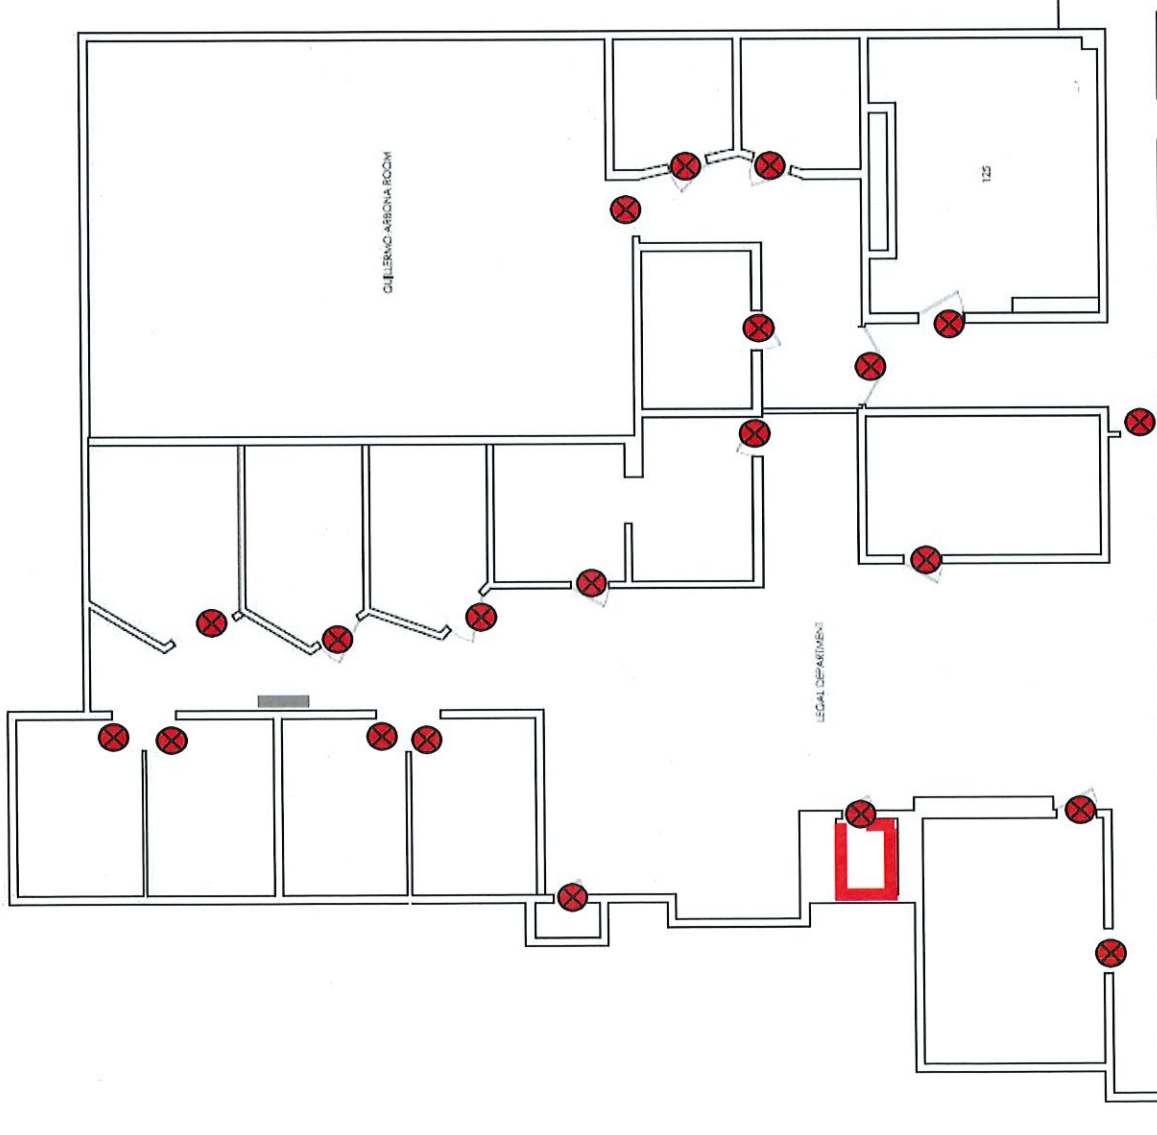
**Legenda: Edificio Principal Piso 1 Área Legal y Área Exterior de Covacha al lado de Almacén Exterior. Área 5 en Plano Esquemático.**

Se presentan las siguientes áreas positiva a LBP.

— Fire Box con LBP.
