# REPORTE DE INSPECCIÓN PINTURA EN BASE DE PLOMO

EN OFICINAS DEL DEPARTAMENTO DE SALUD  
MONACILLO URBANO, AVE. CENTRO MÉDICO, SAN JUAN P.R.

Septiembre, 2019

Preparado por:  
R & S Professional Equipment, Inc.  
PO Box 289, Naguabo, P.R. 00718  
Phone: (787) 637-7267  
Email. rsprofessionalequipment@gmail.com

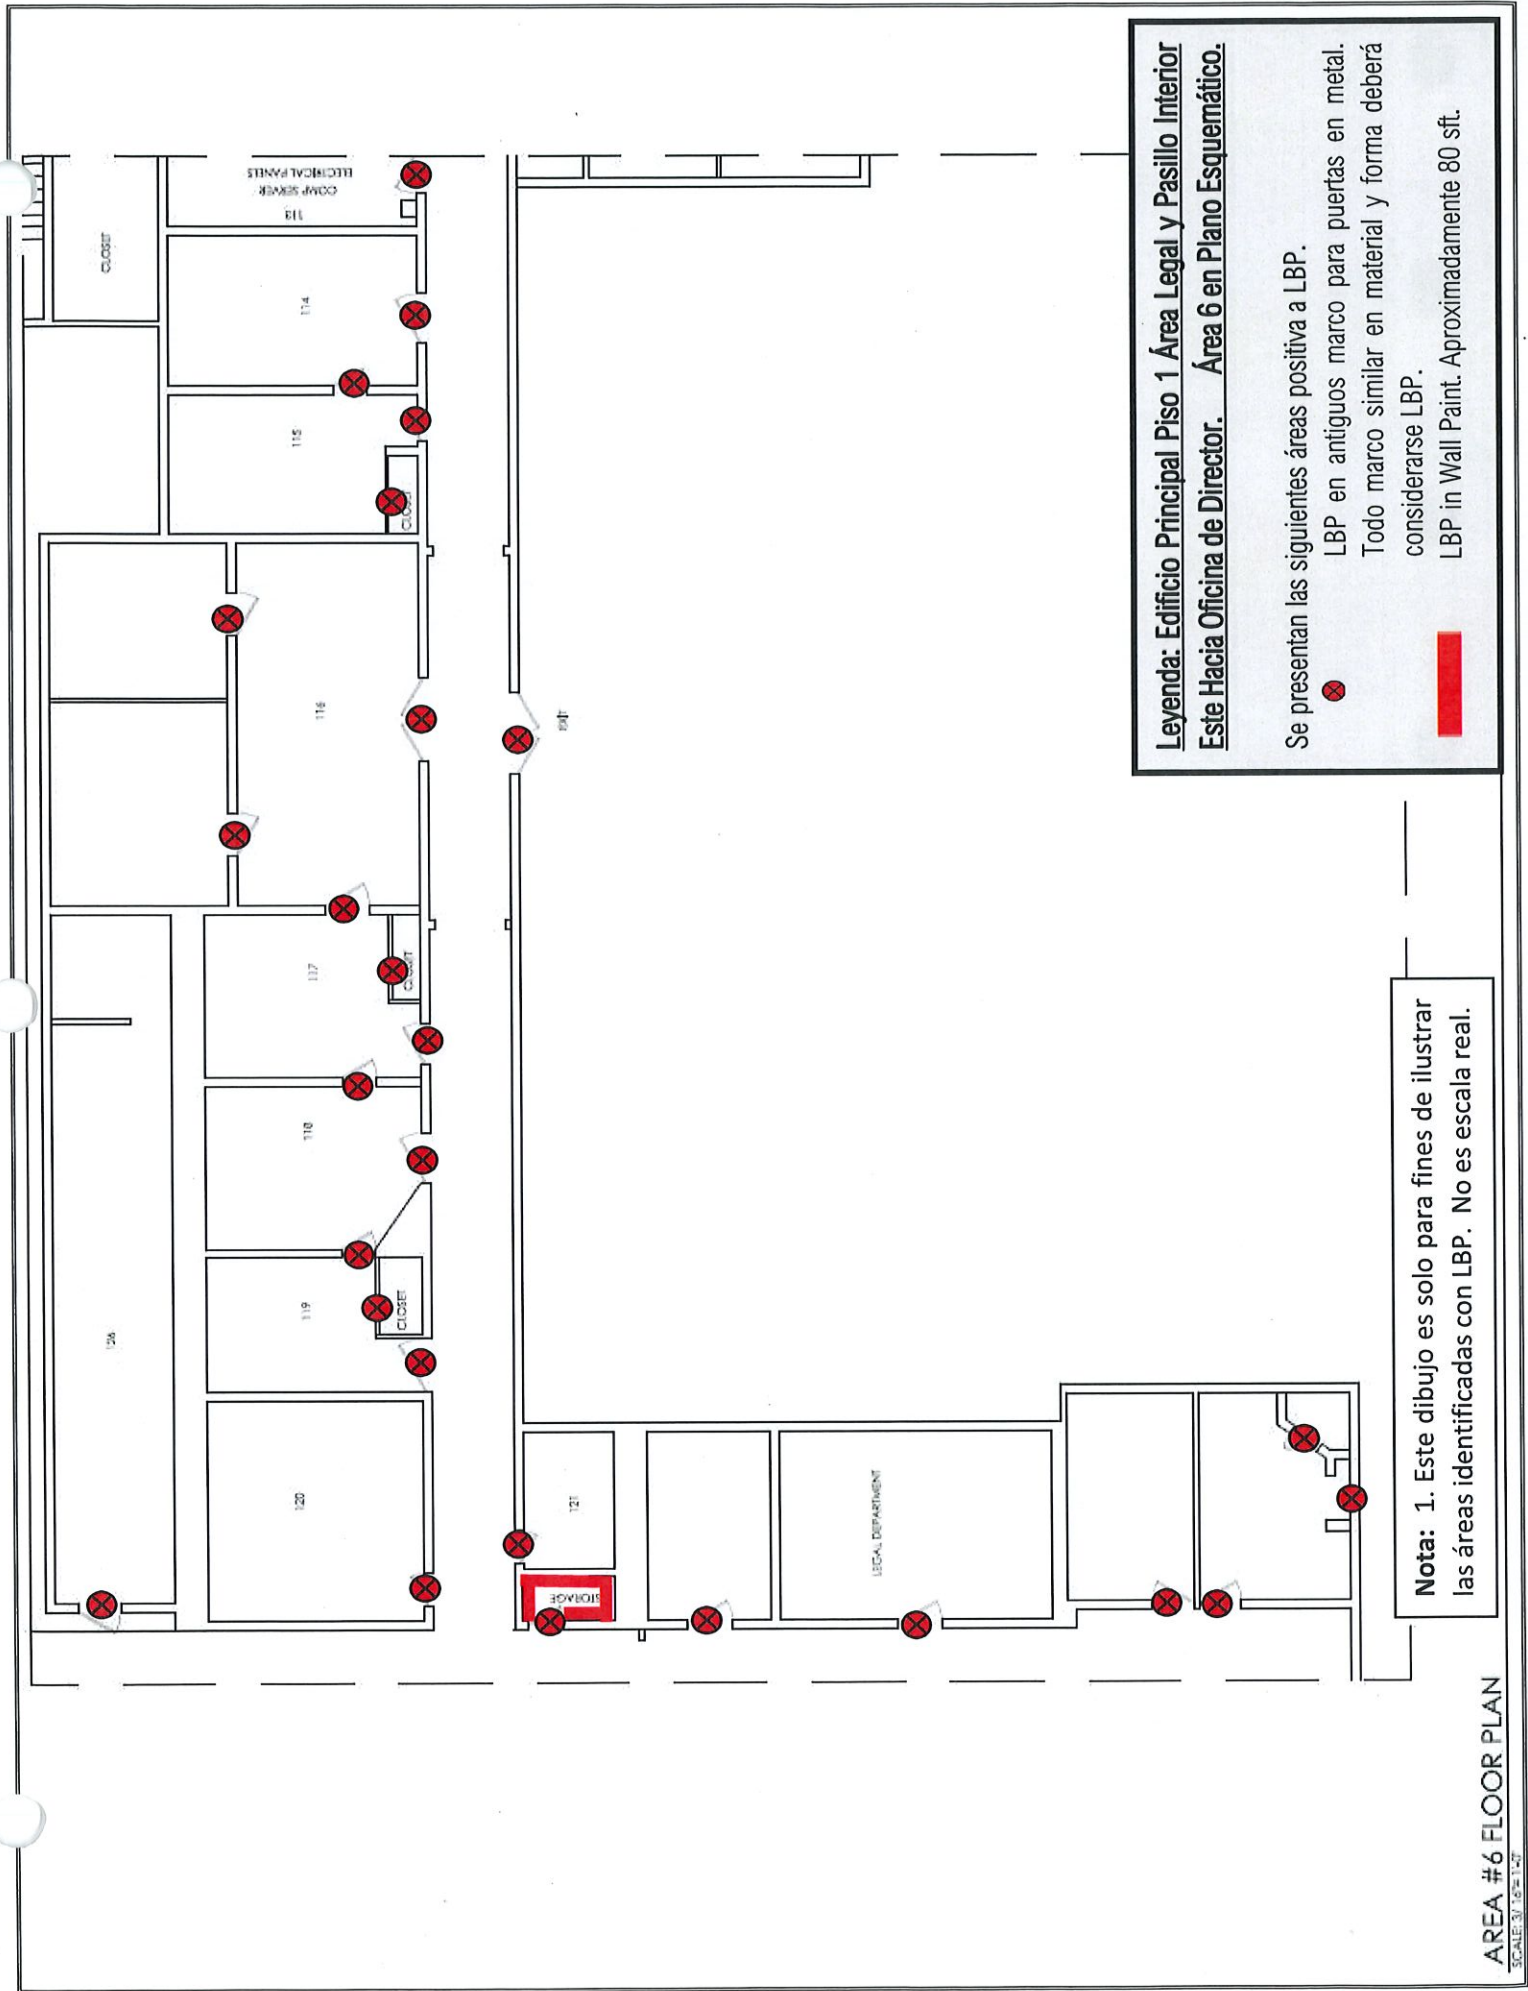
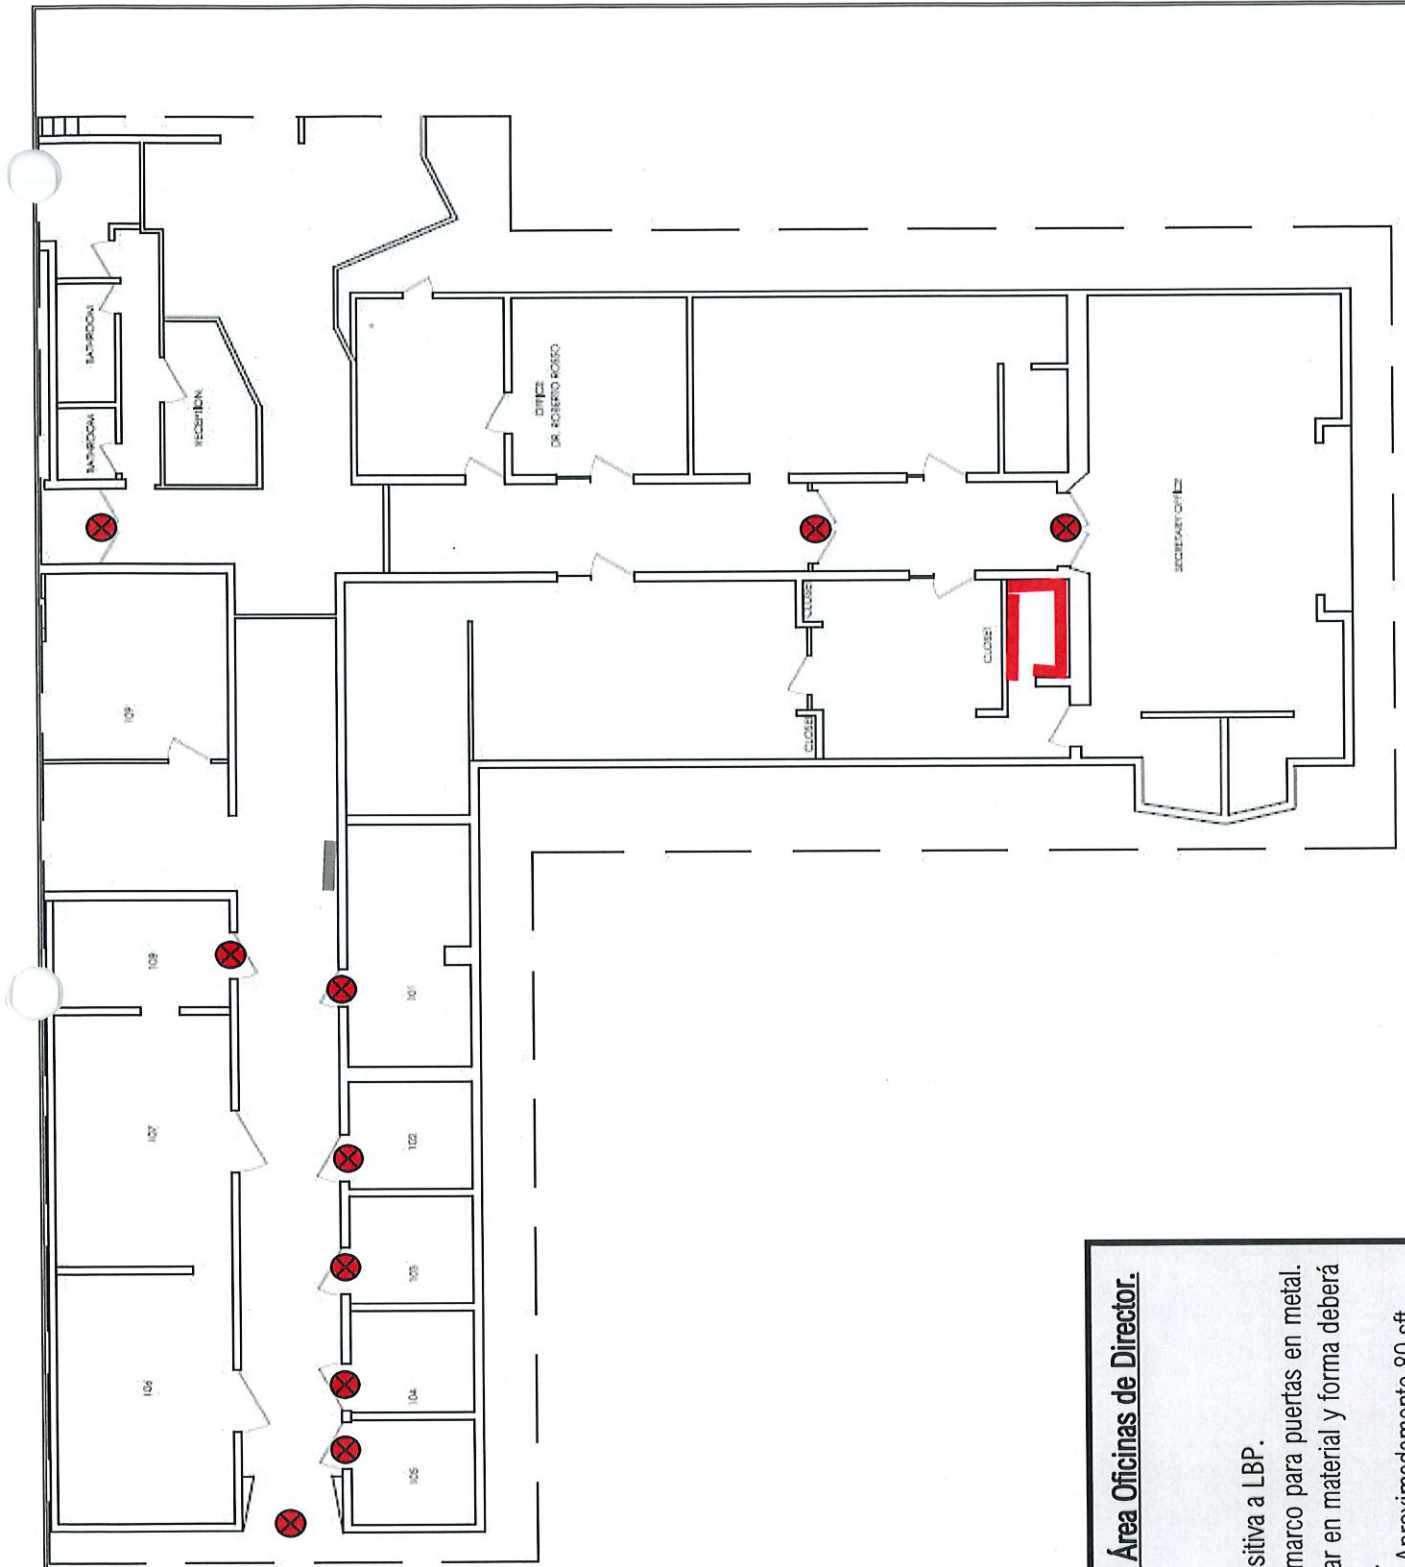
**Leyenda: Edificio Principal Piso 1 Área Oficinas de Director.  
Área 7 en Plano Esquemático.**

Se presentan las siguientes áreas positiva a LBP.

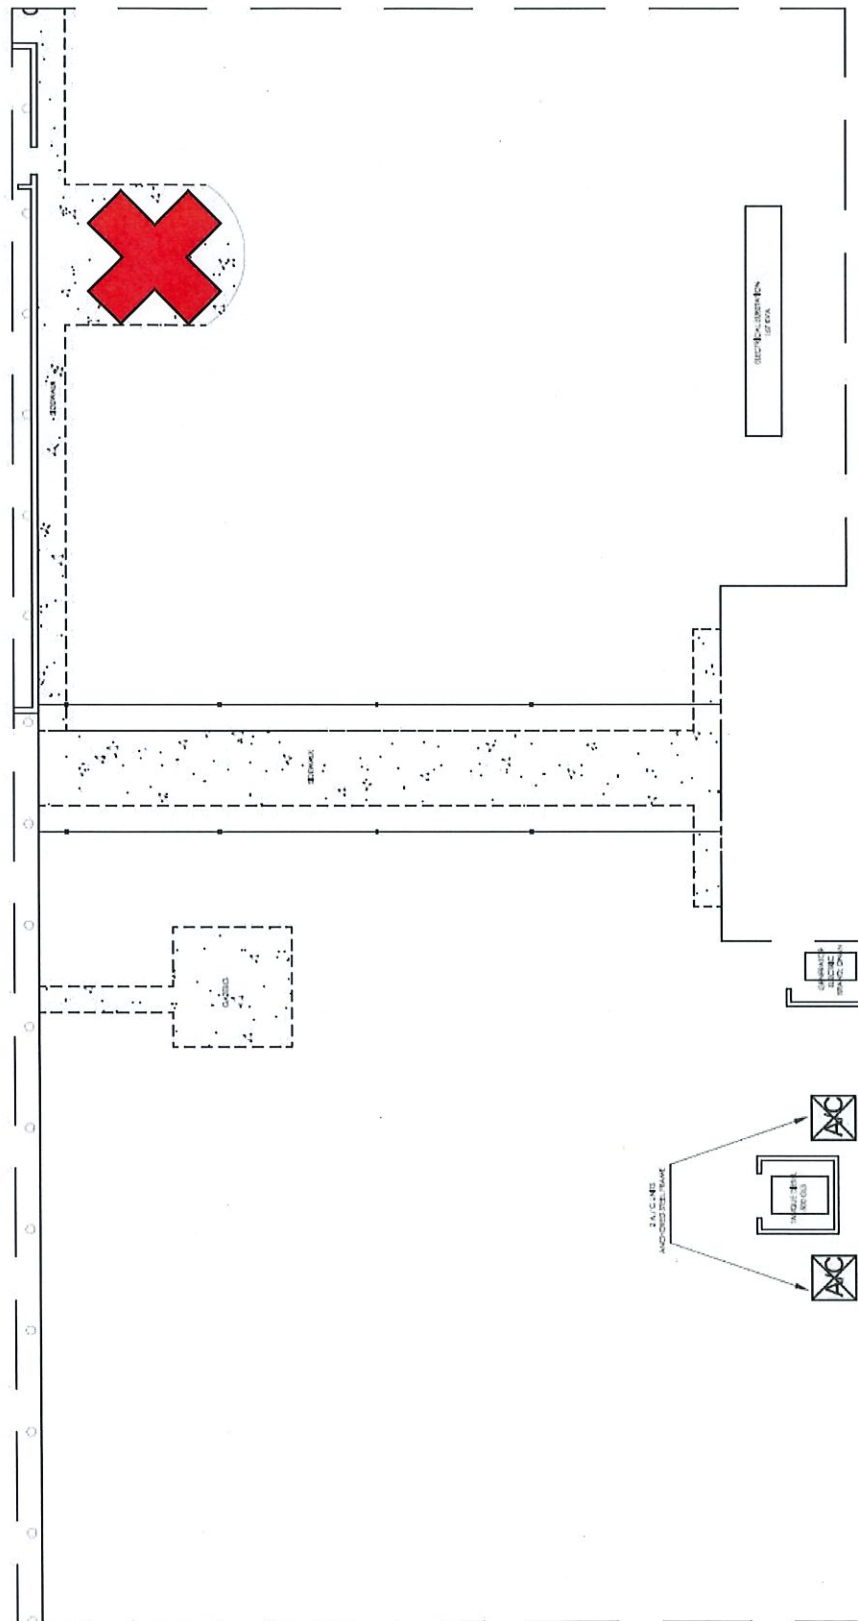
**Legenda: Edificio Principal Piso 1 Patio Central**  
**Área 9 en Plano Esquemático.**

Se presentan las siguientes áreas positiva a LBP.  
 X Se identificó LBP en la cerámica de todos los bancos y mesas con mosaico (4 sets).

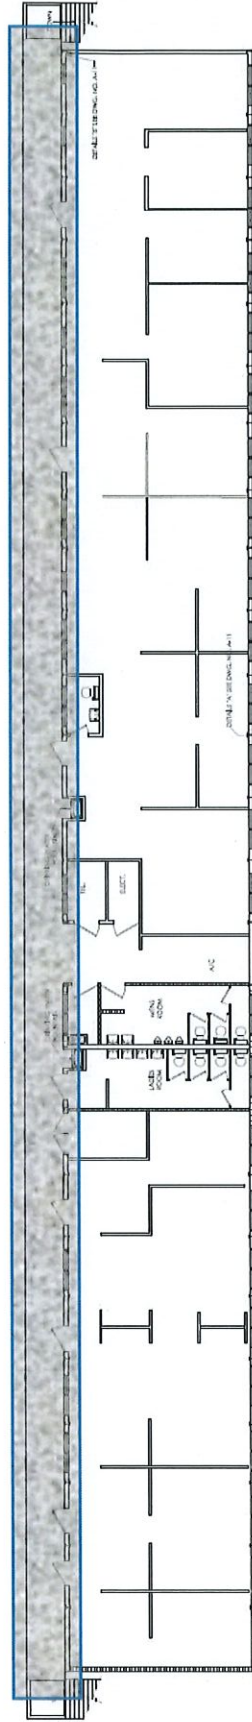
**Leyenda: Pabellón #2 Piso 2. Pasillo de Corredor**  
**Página 005 de Plano Esquemático.**

Se presentan las siguientes áreas positiva a LBP, cantidades y medidas deberán ser corroboradas.

■ Pintura LBP en paredes.

■ Cerámica LBP en piso exterior.  
 Aproximadamente 90 sft.
