**REPORTE DE INSPECCIÓN DE MATERIALES CON**  
**CONTENIDO DE ASBESTO**

**EN OFICINAS DEL DEPARTAMENTO DE SALUD**  
**MONACILLO URBANO, AVE. CENTRO MÉDICO, SAN JUAN P.R.**

**Septiembre, 2019**

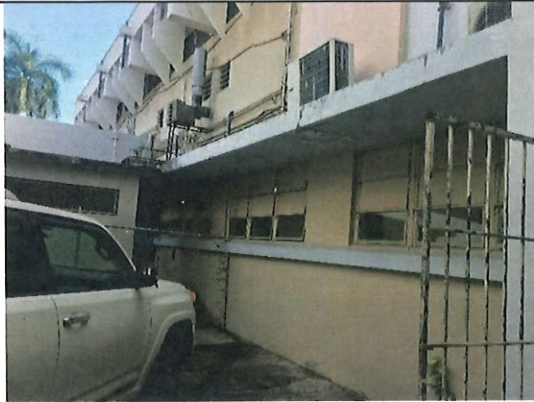
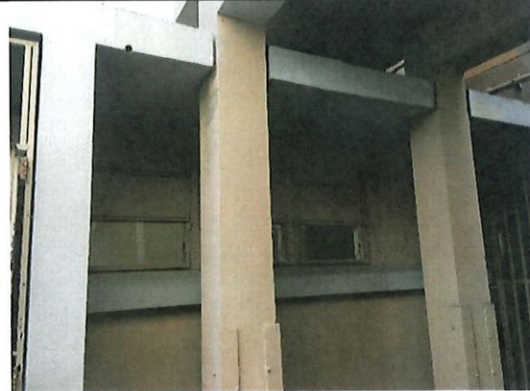
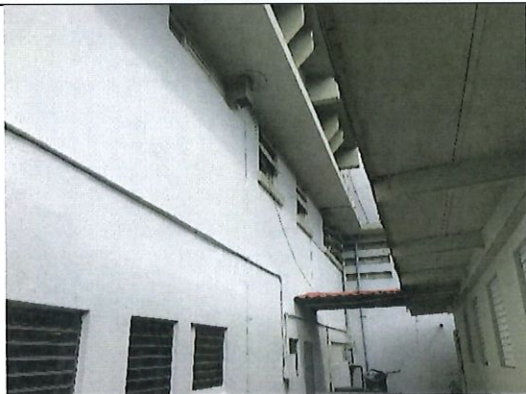
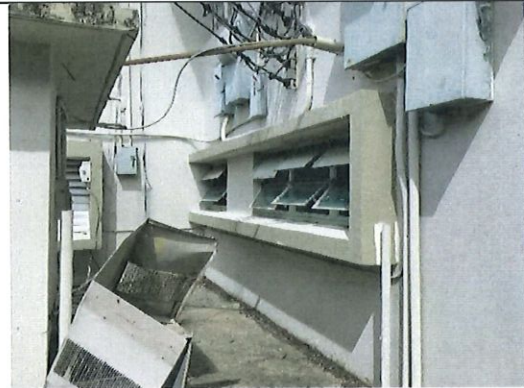
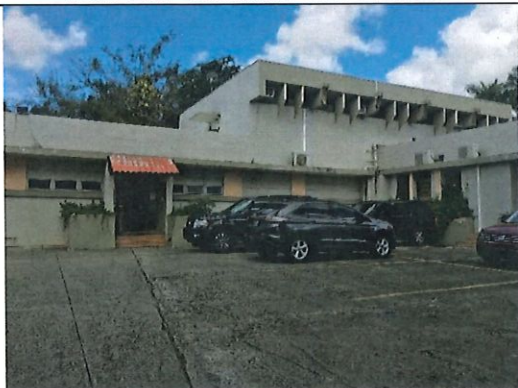
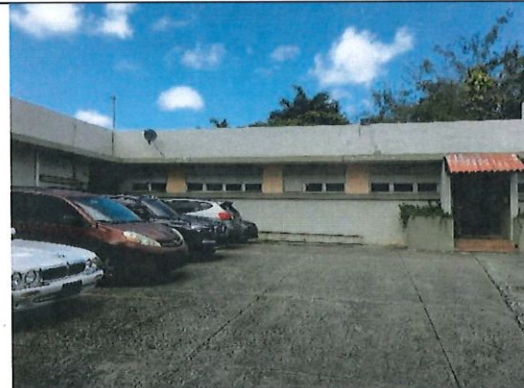
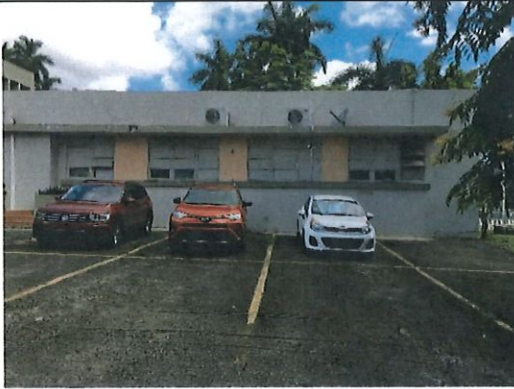
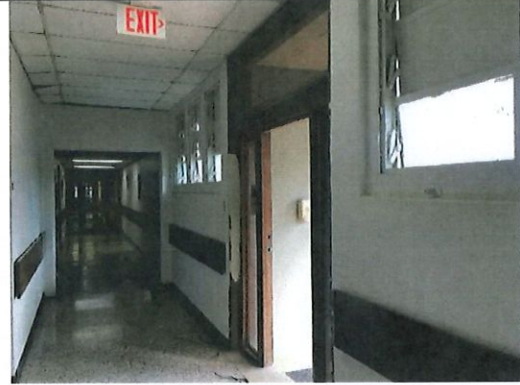
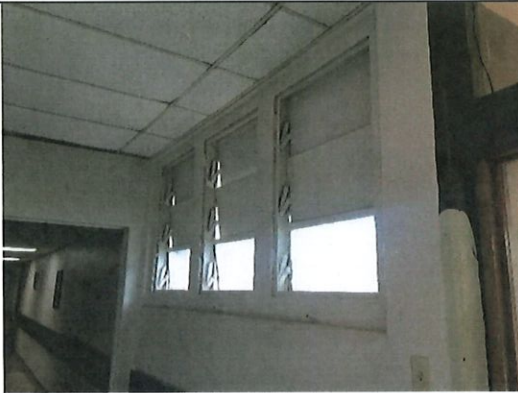
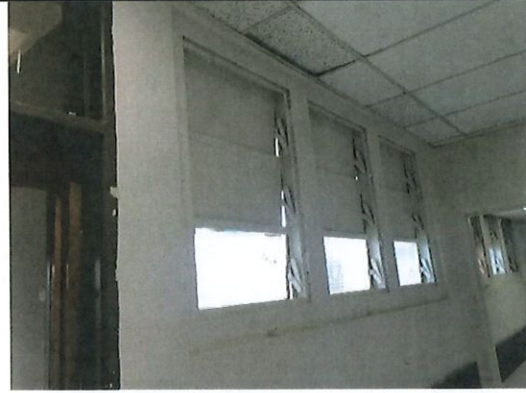
Foto 19. Ventanas con Transite

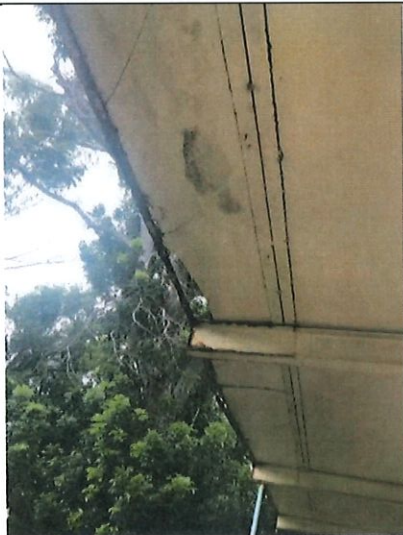
Foto 29. Transite en techo

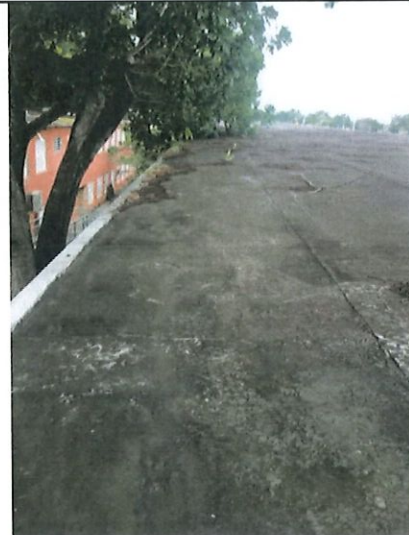
Concluimos con la mención de la existencia de áreas en las que el deterioro llega a niveles tales que se percibe mal olor, se observa hongo en equipos, paredes, piso, plafón acústico, y demás áreas. Sobre el techo acústico de los pasillos del primer nivel del edificio principal, hay desprendimiento de empañetado de material negativo a Asbestos, no obstante, contiene otro tipo de fibra. Este material deteriorado se observa que previamente ha sido perturbado. En adición en área de pabellones existen materiales positivos a Asbestos perturbados de su estado original y expuesto, como lo es el material de impermeabilización y paneles de Transite. Esto representa un riesgo inmediato.

Foto 30. Roofing Material deteriorado

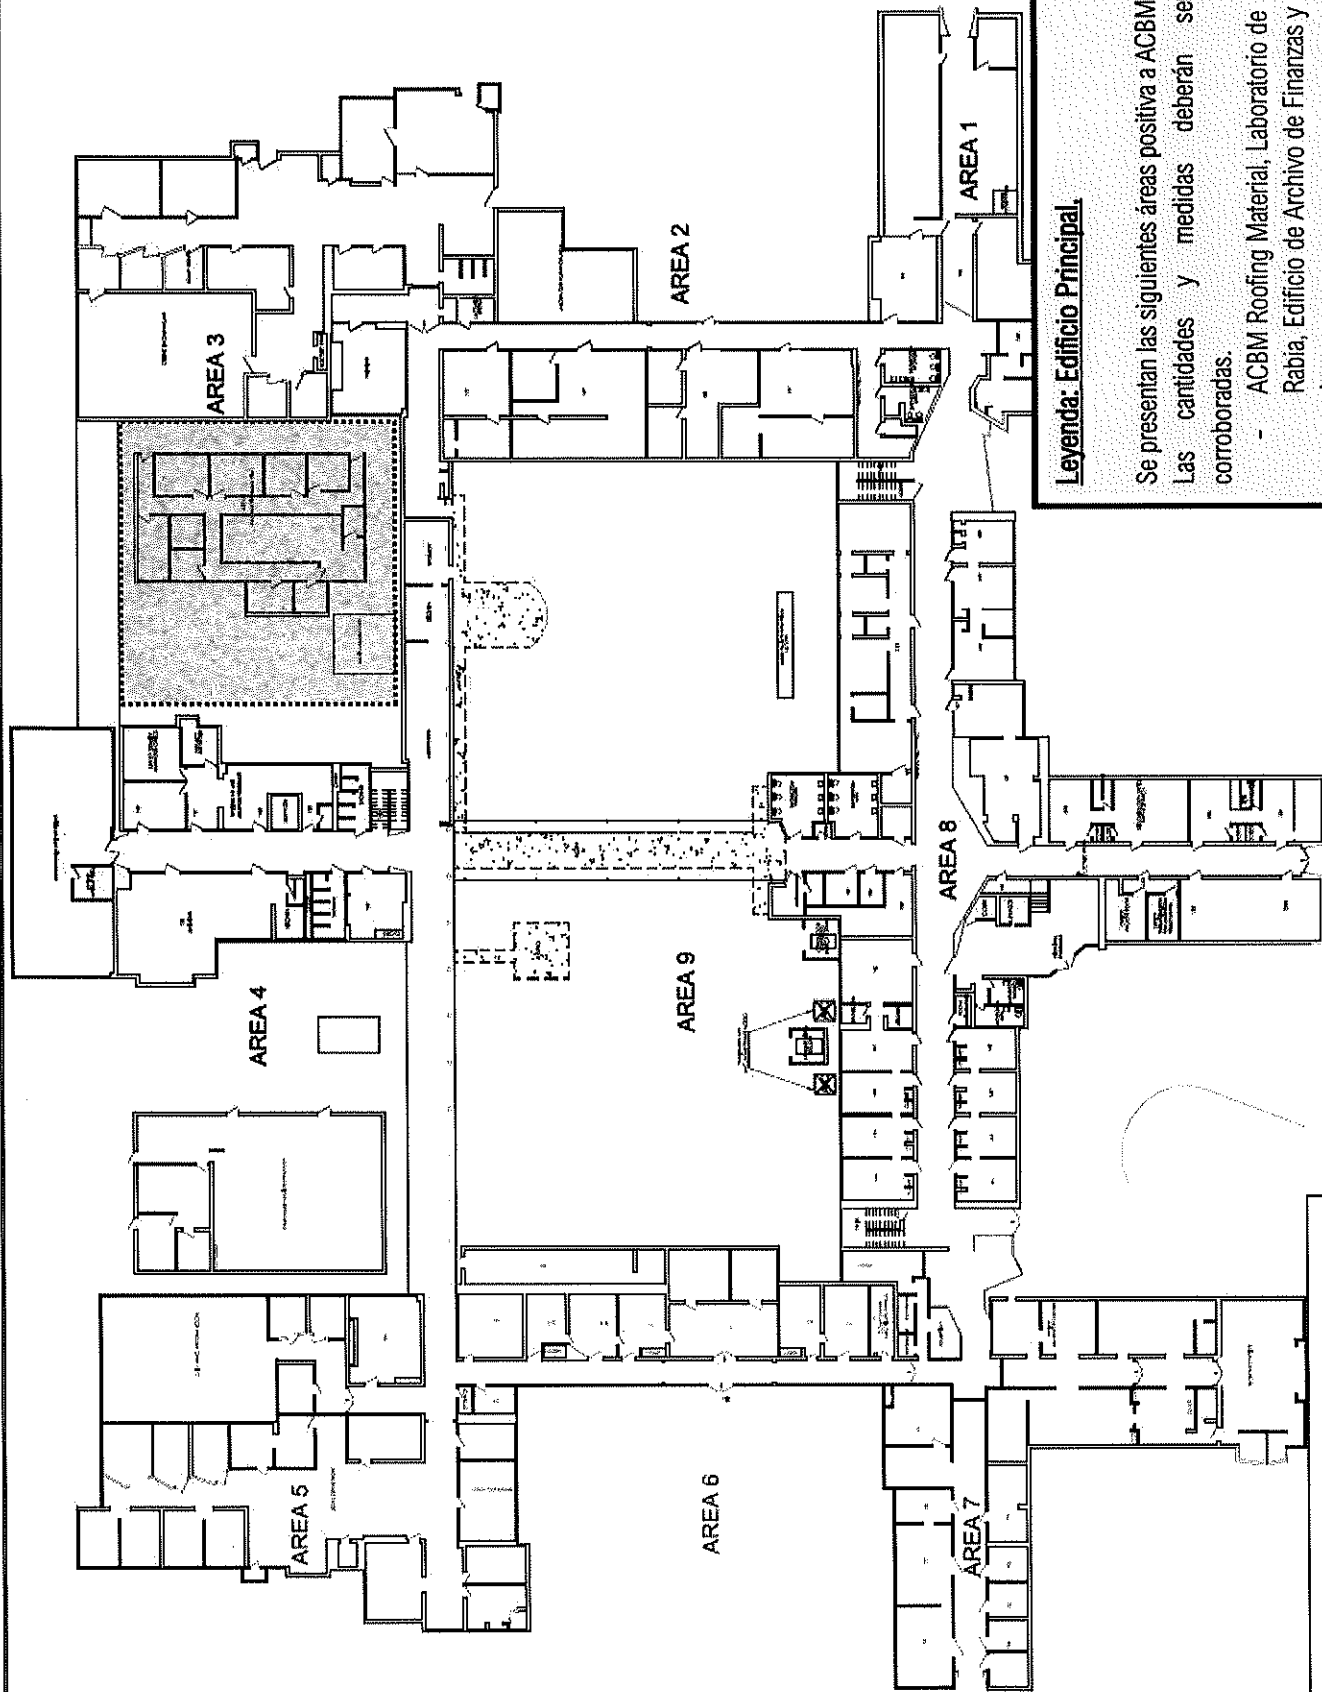
**Leyenda: Edificio Principal.**

- ACBM Roofing Material, Laboratorio de Rabia, Edificio de Archivo de Finanzas y Anexo.

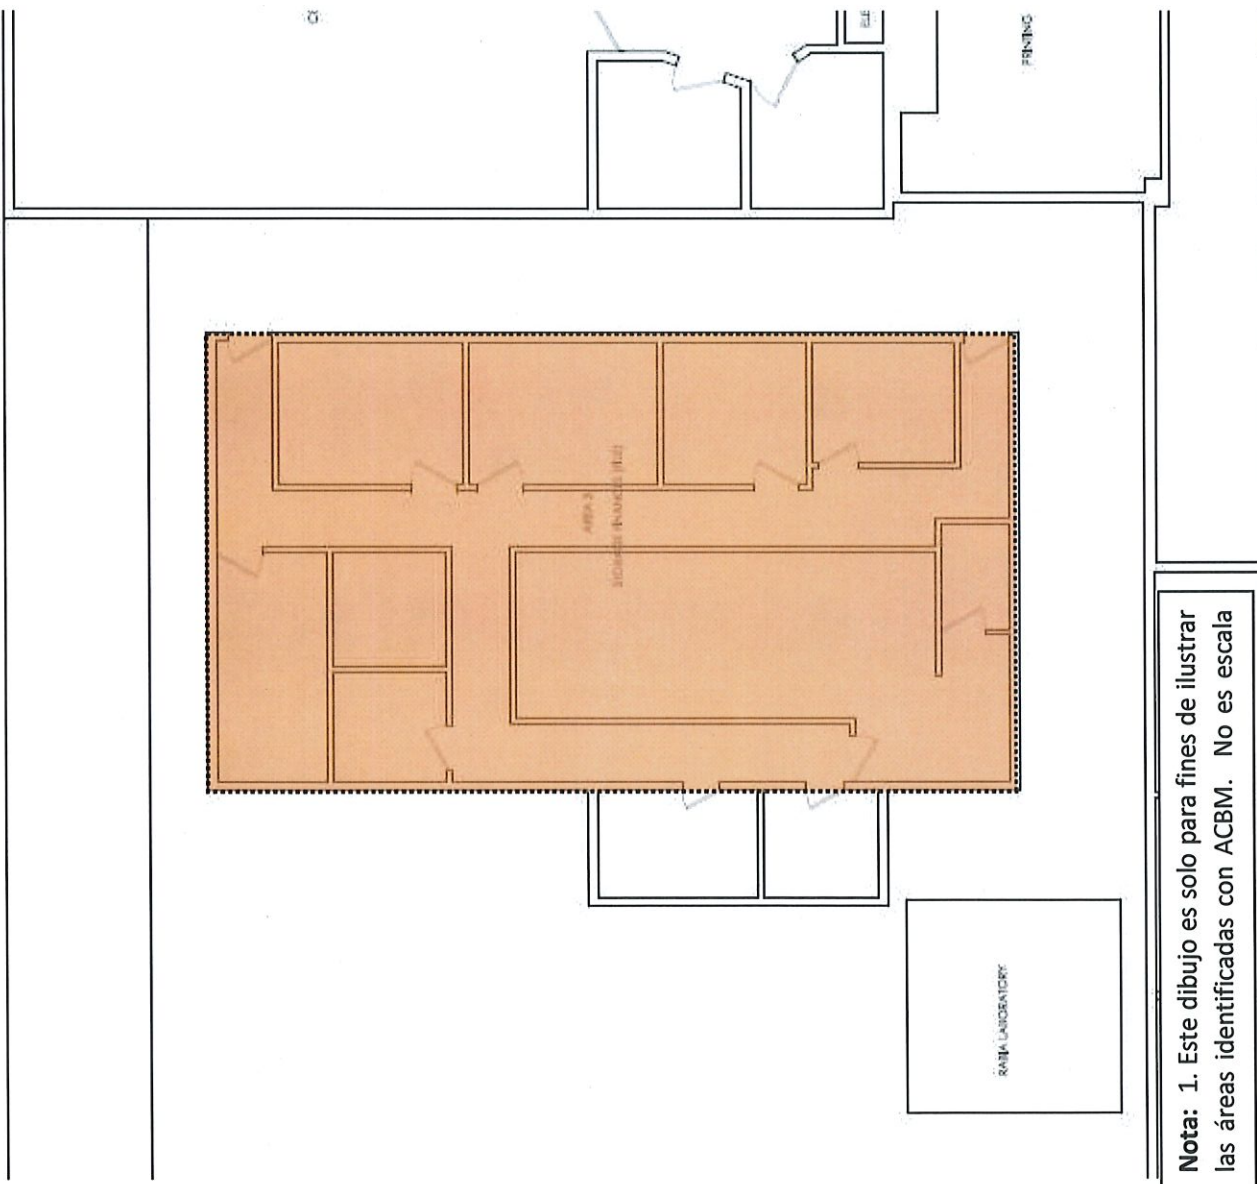
**Leyenda: Edificio de Archivo de Finanzas.**  
**Área 3 de Plano Esquemático.**

- Techos con Transite, ACBM en techos de Edificio de Archivo de Finanzas. **Ver hoja de Notas aplicables para los pabellones 1, 2, 3, 4 y "Storage Finances Building"**
