**LIMITED ENVIRONMENTAL SURVEY  
FOR  
LEAD BASED PAINT (LBP)  
AND  
ASBESTOS CONTAINING MATERIALS (ACM)  
FOR  
CDT ADJUNTAS  
LOCATED ON #4, DR DEFENDINI STREET  
ADJUNTAS, PUERTO RICO**

Prepared For:  
Department of Health

Prepared By:

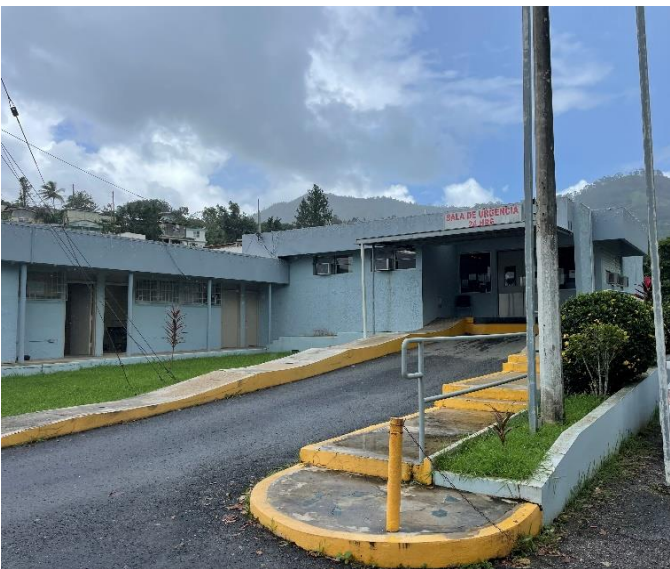
| Bollard | Metal | Yellow |

**Yellow Concrete Curb, Riser and Bollard  
Painted with LBP  
Emergency Area, Exterior**

*\*All positive findings are not part of scope of work listed under FEMA DISASTER 4339DR-PR and 4473DR-PR contract (Project #:77703, DI#151659).*

If remodeling activities will be conducted in the nearest future, it is required to remove all LBP materials prior to performance of said activities.

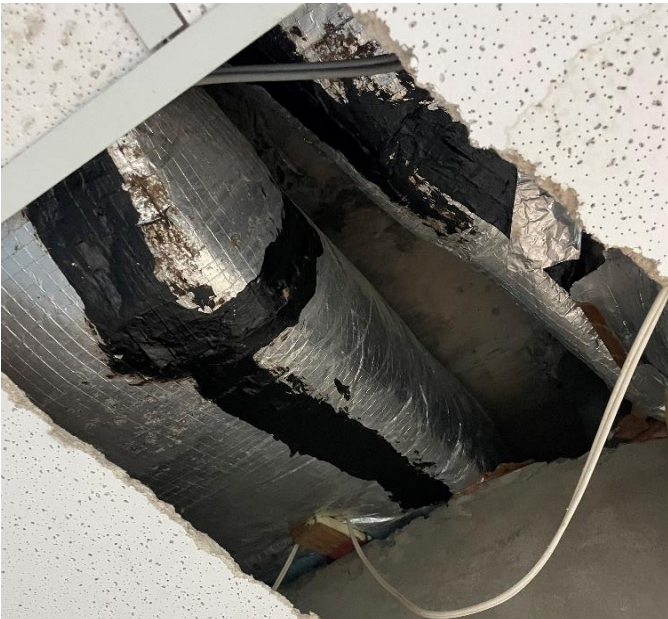
| Lab Sample ID<br>Client Sample ID | Sample Description | Asbestos Detected | Asbestos Fibers | Other Fibers | Non - Fibrous Material |
|---|---|---|---|---|---|
| Date Analyzed: 10/13/2022<br>Sample Location: Black Mastic on HVAC, Area 1-87<br>Comments:<br>Asbestos Found in Bitumen | | | | | |

| Lab Sample ID<br>Client Sample ID | Sample Description | Asbestos Detected | Asbestos Fibers | Other Fibers | Non - Fibrous Material |
|---|---|---|---|---|---|
| <b>B22100019.25</b><br>B22100019.25.A<br>CDT-A-ER25<br>Layer % of Total :100%<br>Date Analyzed: 10/13/2022<br>Sample Location: Black Mastic on HVAC from Area 1-54<br>Comments:<br>Asbestos Found in Bitumen | Semi-Hard, Fibrous with Aluminum<br>Other - and Black Mastic Pink | Yes | Chrysotile 3 | Cellulose 20<br>Glass Fibers 30 | Aluminum 15<br>Bitumen 32 |

**Typical Asbestos Containing Black Mastic  
on HVAC**

If demolition/remodeling activities will be conducted in the nearest future it is recommended to remove all ACM known, suspected, or presumed present within the structure, as to comply with NESHAP/DRNA requirements.

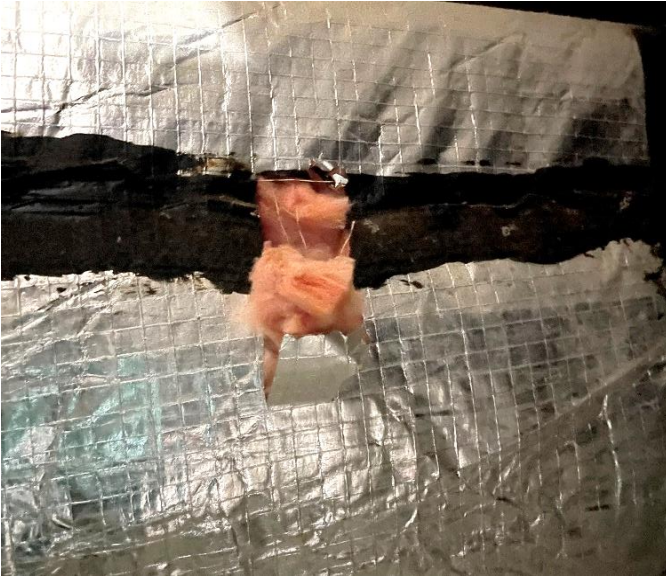
**Typical Asbestos Containing Black Mastic  
on HVAC**

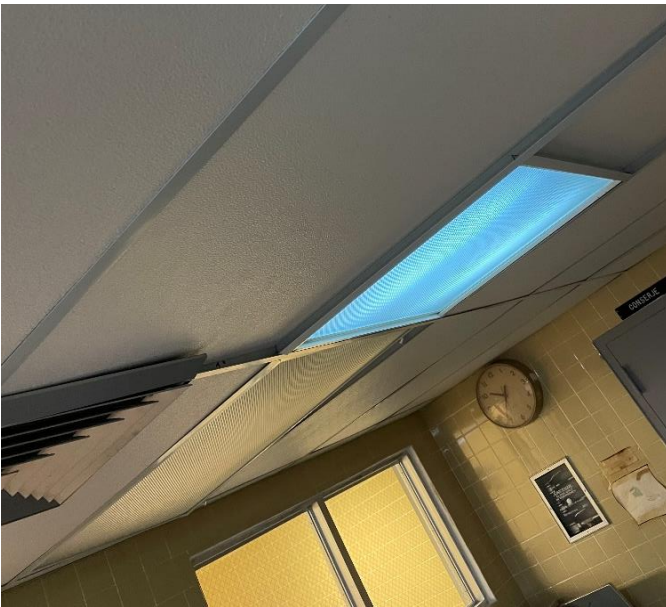
| Building | Sample ID | Description | Result (Percentage of Asbestos) |
|---|---|---|---|
| | CDT-A-ER28 | Ceiling Tile 2'x 4' (Transite) from Area 1-59 | 10% CHR |

**Typical Asbestos Containing Ceiling Tiles  
2'x 4' (Transite)**

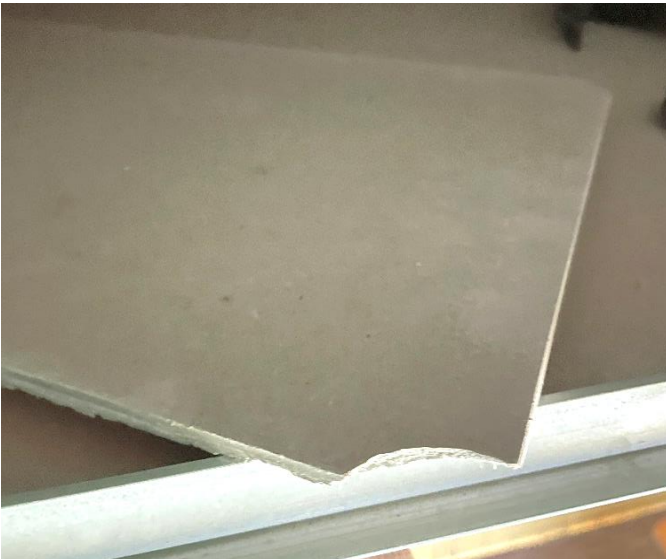
**Typical Asbestos Containing Ceiling Tiles  
2'x 4' (Transite)**
