# LEAD BASED PAINT INSPECTION REPORT

PUERTO RICO DEPARTMENT OF HEALTH

SAMPLING CONDUCTED AT  
RAMÓN RUIZ ARNAU UNIVERSITY HOSPITAL  
2ND LEVEL WARD B & DELIVERY ROOMS  
BAYAMÓN, PR

ZEM-21291

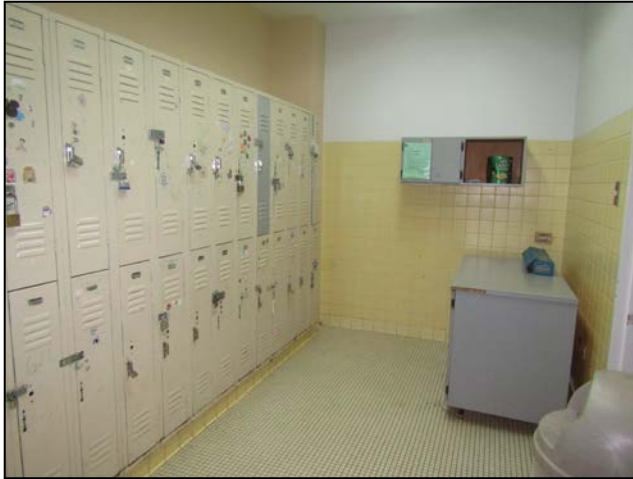
**2<sup>nd</sup> Level Ward B**  
Lead containing ceramic wall tiles.

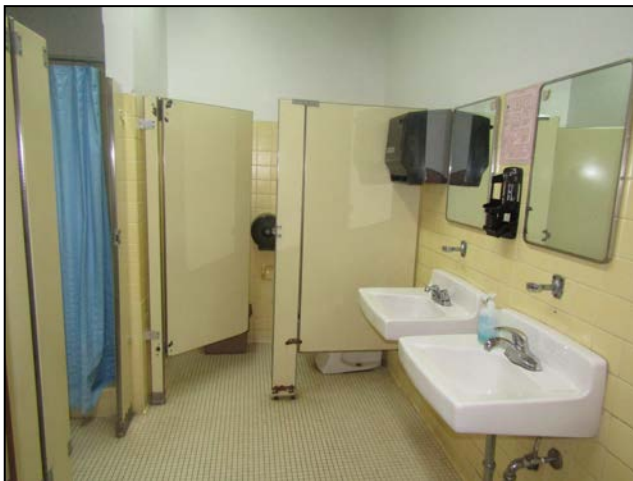
**2<sup>nd</sup> Level Ward B**  
Lead containing ceramic wall tiles.

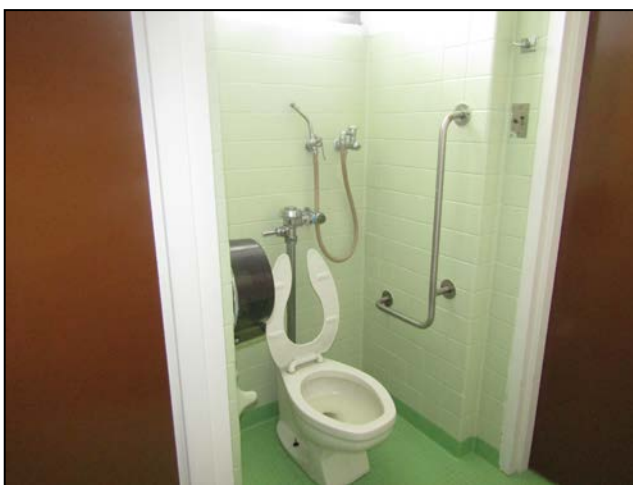
**2<sup>nd</sup> Level Ward B**  
Lead containing ceramic wall tiles.

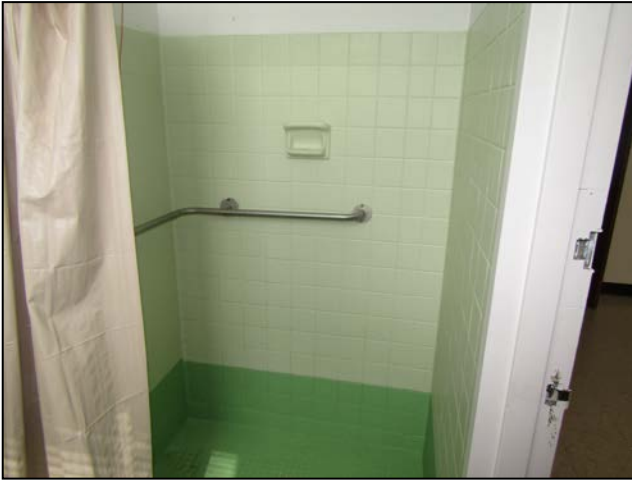
**2<sup>nd</sup> Level Ward B**  
Lead containing ceramic wall tiles.

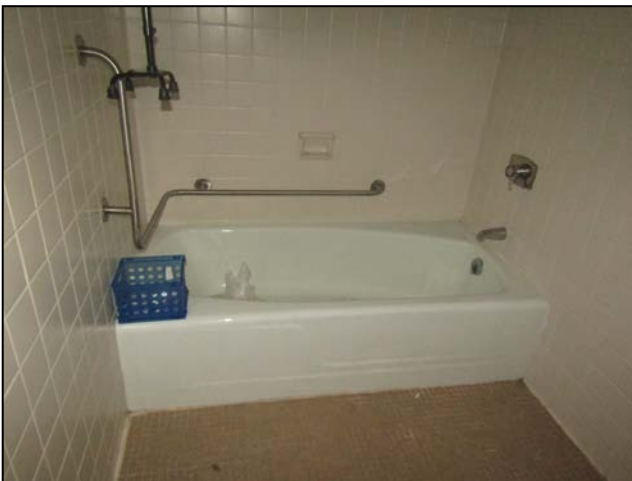
At the 2<sup>nd</sup> level Ward B area, a ceramic bathtub, in addition to ceramic wall tiles tested resulted positive for lead above the regulatory limit of 1.0 mg/cm<sup>2</sup>. Individual components that are classified positive should be considered as being lead-based painted and managed or abated appropriately. If these surfaces will be disturbed as part of a renovation/demolition project it shall be managed following the DRNA Lead Based Paint Abatement Control Activities Regulation.

**2<sup>nd</sup> Level Ward B**  
Lead containing ceramic bathtub.

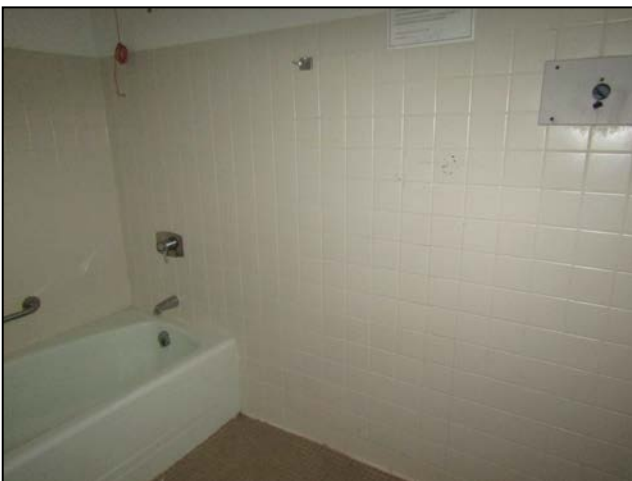
**2<sup>nd</sup> Level Ward B**  
Lead containing ceramic wall tiles.
