# REPORTE DE INSPECCIÓN PINTURA EN BASE DE PLOMO

EN OFICINAS DEL DEPARTAMENTO DE SALUD  
MONACILLO URBANO, AVE. CENTRO MÉDICO, SAN JUAN P.R.

Septiembre, 2019

Preparado por:  
R & S Professional Equipment, Inc.  
PO Box 289, Naguabo, P.R. 00718  
Phone: (787) 637-7267  
Email. rsprofessionalequipment@gmail.com

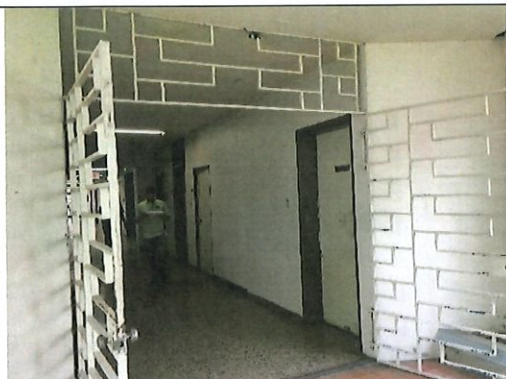
**Foto 25. áreas de Rejas de acero.  
Pasillo hacia Cafetería**

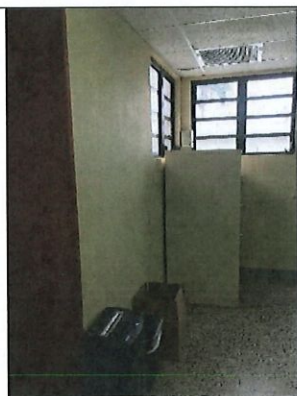
**Foto 31. LBP en pared de concreto en Oficina 128**

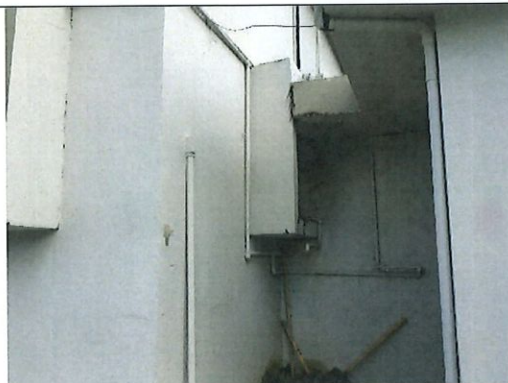
**Foto 38. LBP en "Exterior Eave", Area Sur, Subestación Eléctrica y Salud.**

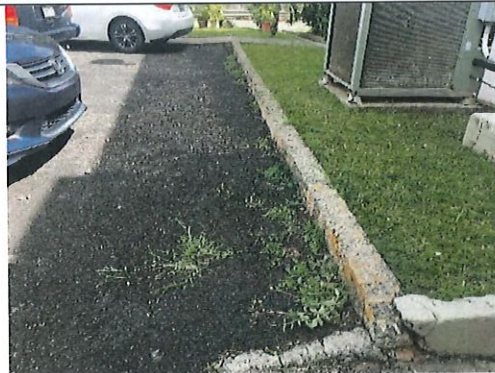
**Foto 64. de encintado con LBP amarillo en estacionamientos. Área Sur Este.**
