**REPORTE DE INSPECCIÓN DE MATERIALES CON**  
**CONTENIDO DE ASBESTO**

**EN OFICINAS DEL DEPARTAMENTO DE SALUD**  
**MONACILLO URBANO, AVE. CENTRO MÉDICO, SAN JUAN P.R.**

**Septiembre, 2019**

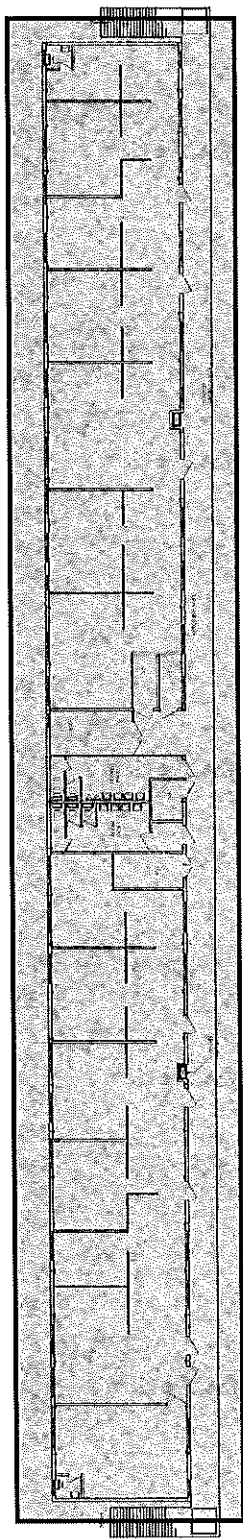
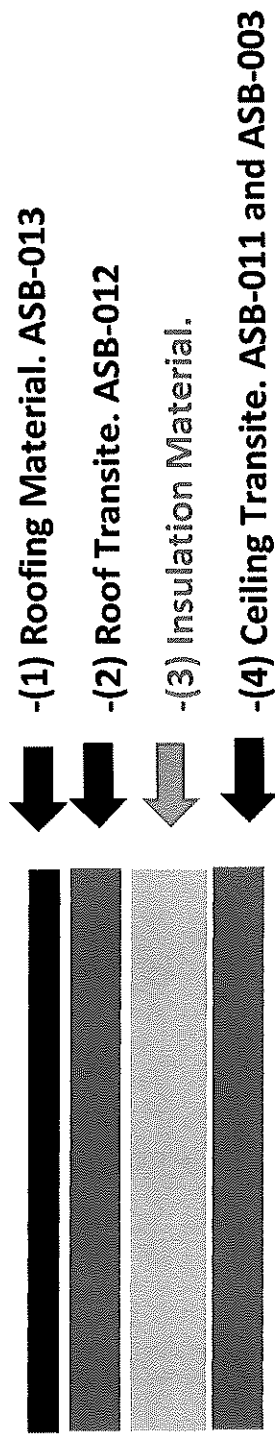
**Pavilion #1 & #2**

1. Los techos están compuestos por las siguientes capas seccionales: (1) Material impermeabilizante o "Roofing Material" con contenido de Asbestos. Ver Muestras ASB-013, ASB-076; (2) Panel Transite con contenido de Asbesto. Ver muestras ASB-ASB-012, ASB-079; (3) Material de aislación (panel de espuma de uretano); Panel de "Ceiling Transite" con contenido de Asbesto. Ver muestras ASB-003, ASB-11. Se considera ACM toda estructura, refuerzo estructural o componente de techo.
2. Los Pabellones 1 y 2 constan de una construcción de dos niveles, la sección divisoria entre el Nivel 1 y Nivel 2, entiéndase el piso del Nivel 2 está construido con panel Transite con contenido de Asbesto. Ver muestra ASB-002, ASB-067. Se considera ACM toda estructura, refuerzo o componente de esta sección.

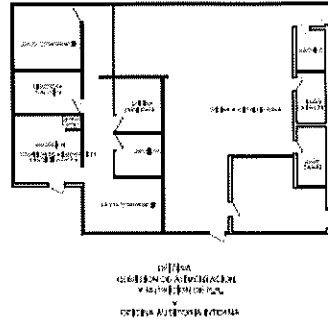
PAVILION 4

- ACBM Roofing Material en techos de Pabellones 1, 2, 3 y 4.

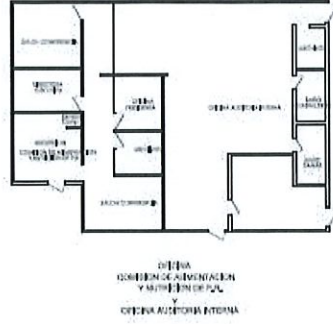
PAVILLION 4

- Techos con Transite, ACBM en techos de Pabellones 1, 2, 3 y 4. Ver hoja de Notas aplicables para los pabellones 1, 2, 3, 4 y "Storage Finaces Building":

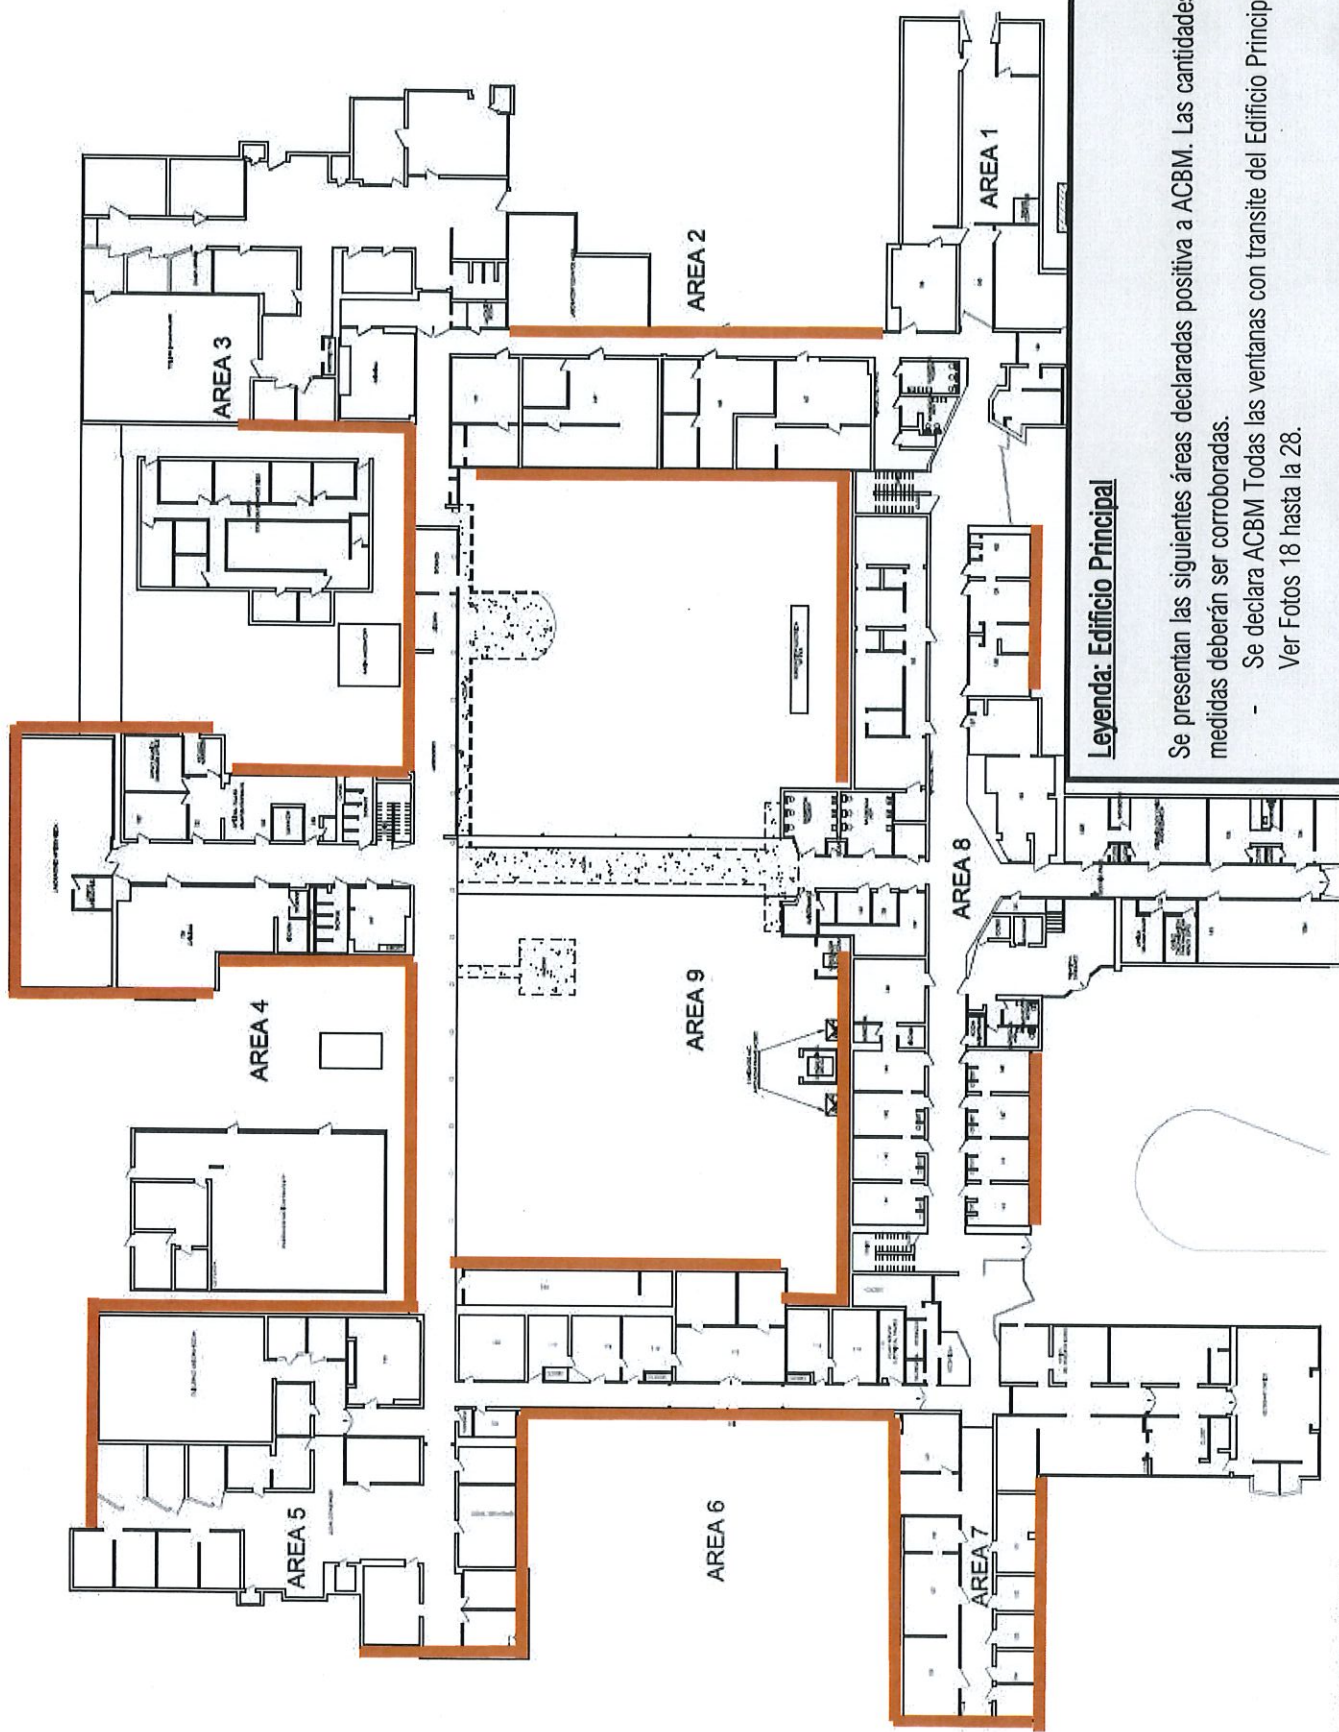
**Leyenda: Edificio Principal**

Se presentan las siguientes áreas declaradas positiva a ACBM. Las cantidades y medidas deberán ser corroboradas.
