# REPORTE DE INSPECCIÓN PINTURA EN BASE DE PLOMO

EN OFICINAS DEL DEPARTAMENTO DE SALUD  
MONACILLO URBANO, AVE. CENTRO MÉDICO, SAN JUAN P.R.

Septiembre, 2019

Preparado por:  
R & S Professional Equipment, Inc.  
PO Box 289, Naguabo, P.R. 00718  
Phone: (787) 637-7267  
Email. rsprofessionalequipment@gmail.com

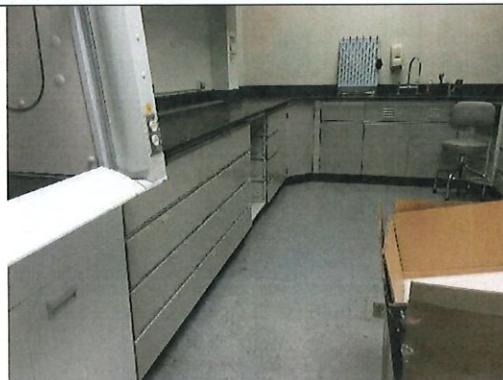
**Foto 18. Escritorios (Extracciones Orgánicas)**

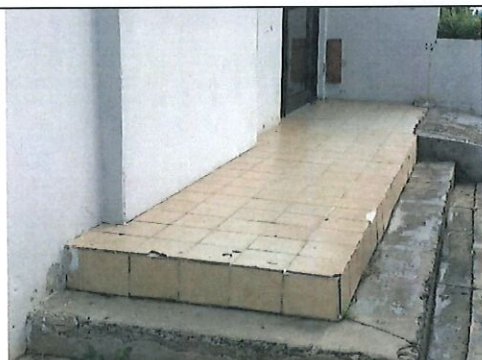
**Foto 35. Cerámica a remover en entrada sur.**

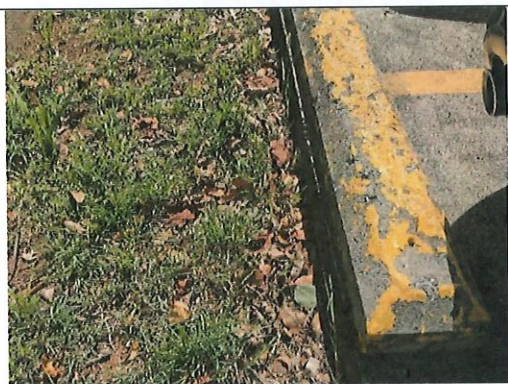
**Foto 63. Wheel stop con LBP amarillo en estacionamientos. Área Sur Este.**
